Google Glass In-Service Road Safety Review Pilot Project

Fireseeds North Infrastructure

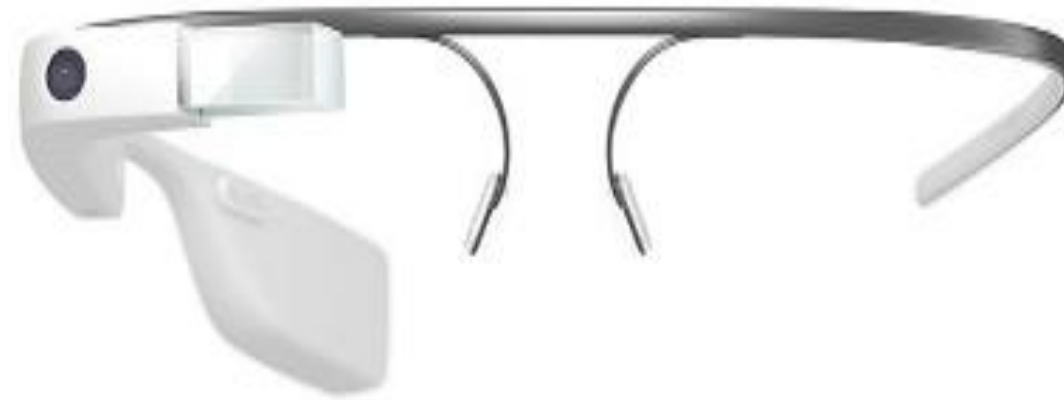
- ▶ **Smart eyewear with projected screen**
 - ▶ **GPS connectivity (Bluetooth)**
- ▶ **Audio, video, photo recording capability**
 - ▶ **Voice commands (hands-free)**
 - ▶ **Preload information**
 - ▶ **Link to online mapping portal**
 - ▶ **Customized applications**

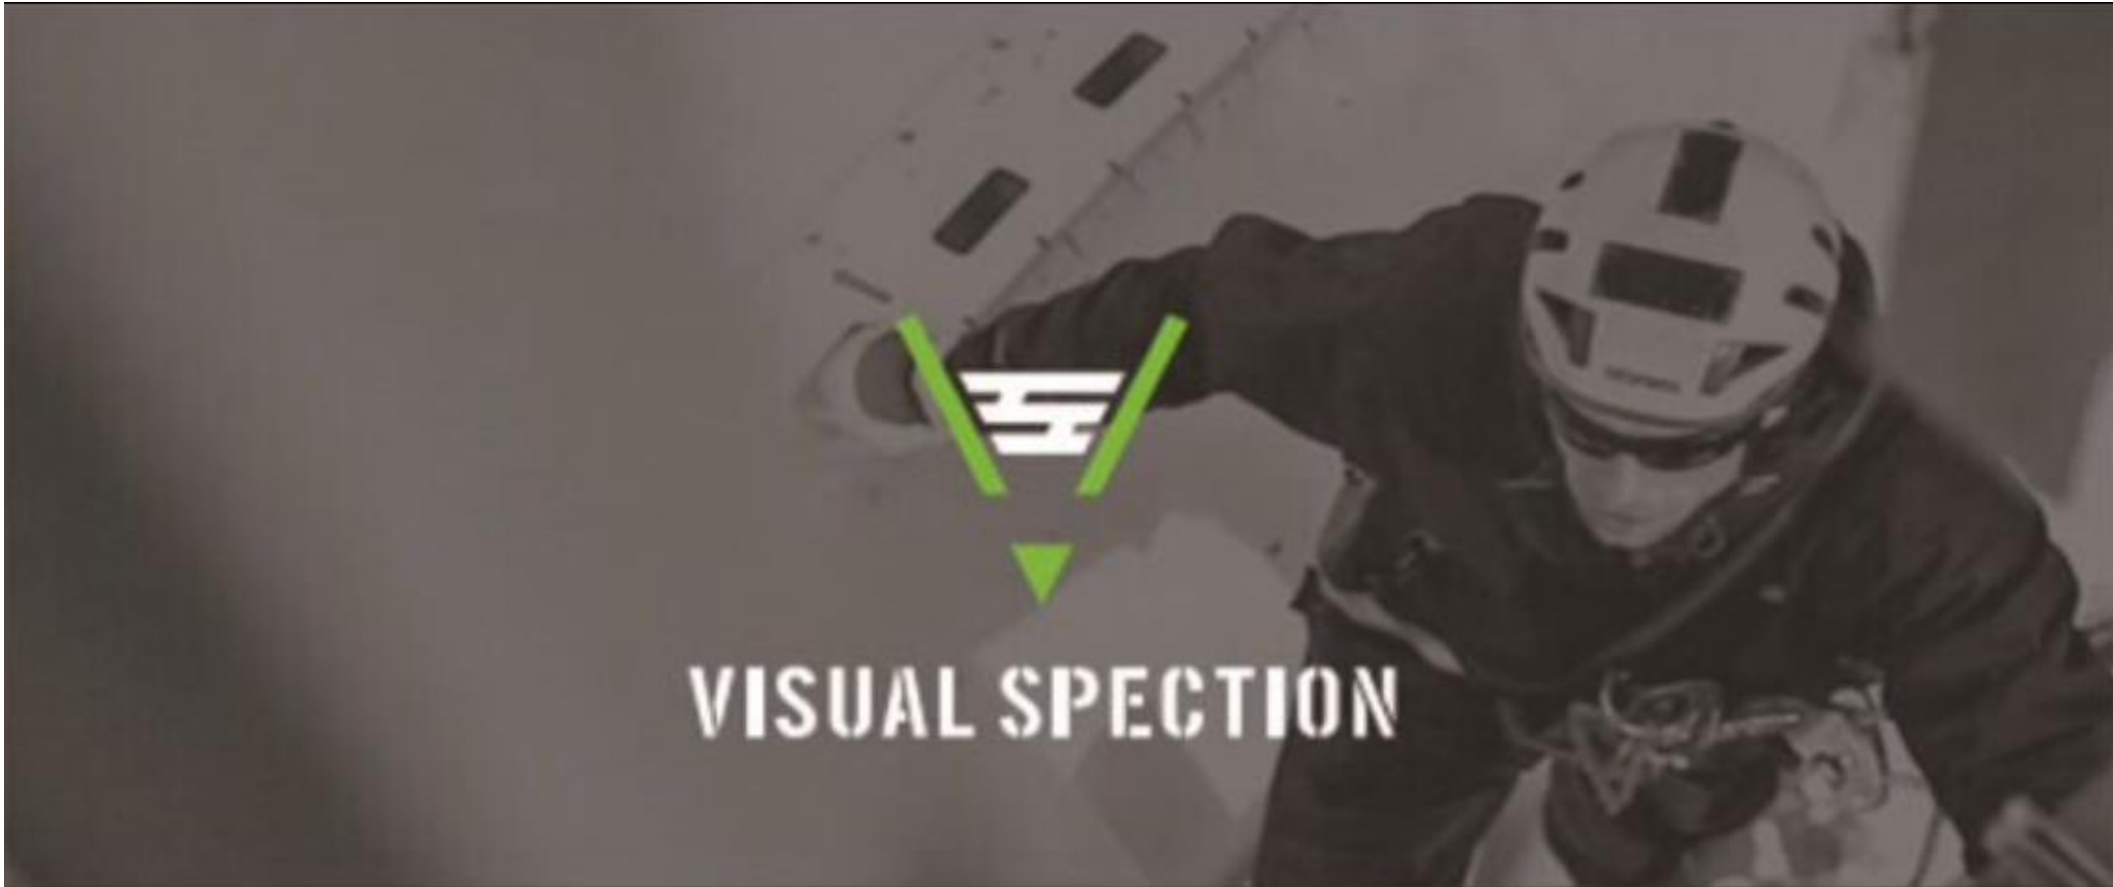
VISUAL SPECTION

☰ 45.42161, -75.69541

Tap for options

Start

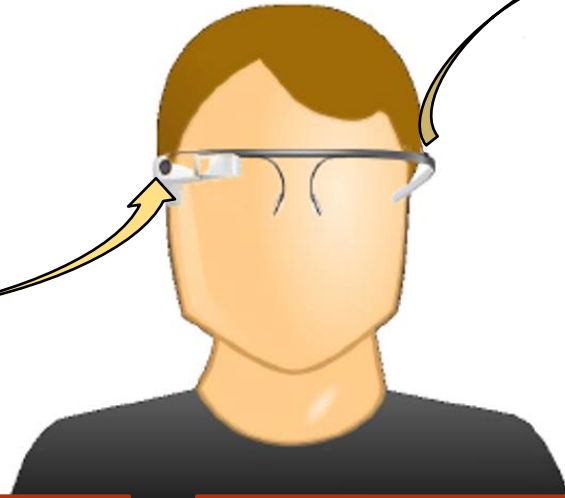
Pre-loaded TAC In-Service Road Safety Review workflow, categories, and reference material

2 injury collisions
Click to view attributes

Pre-loaded collision history with geo-referenced pop-ups during inspection

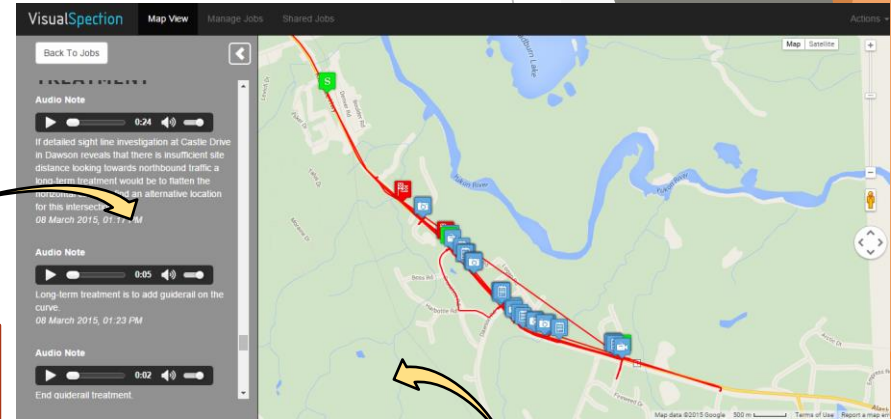
Inspector uses Glass to record field notes, photos, annotated photos and video of safety issues and treatments

Recordings are transcribed, geo-referenced and uploaded to mapping portal

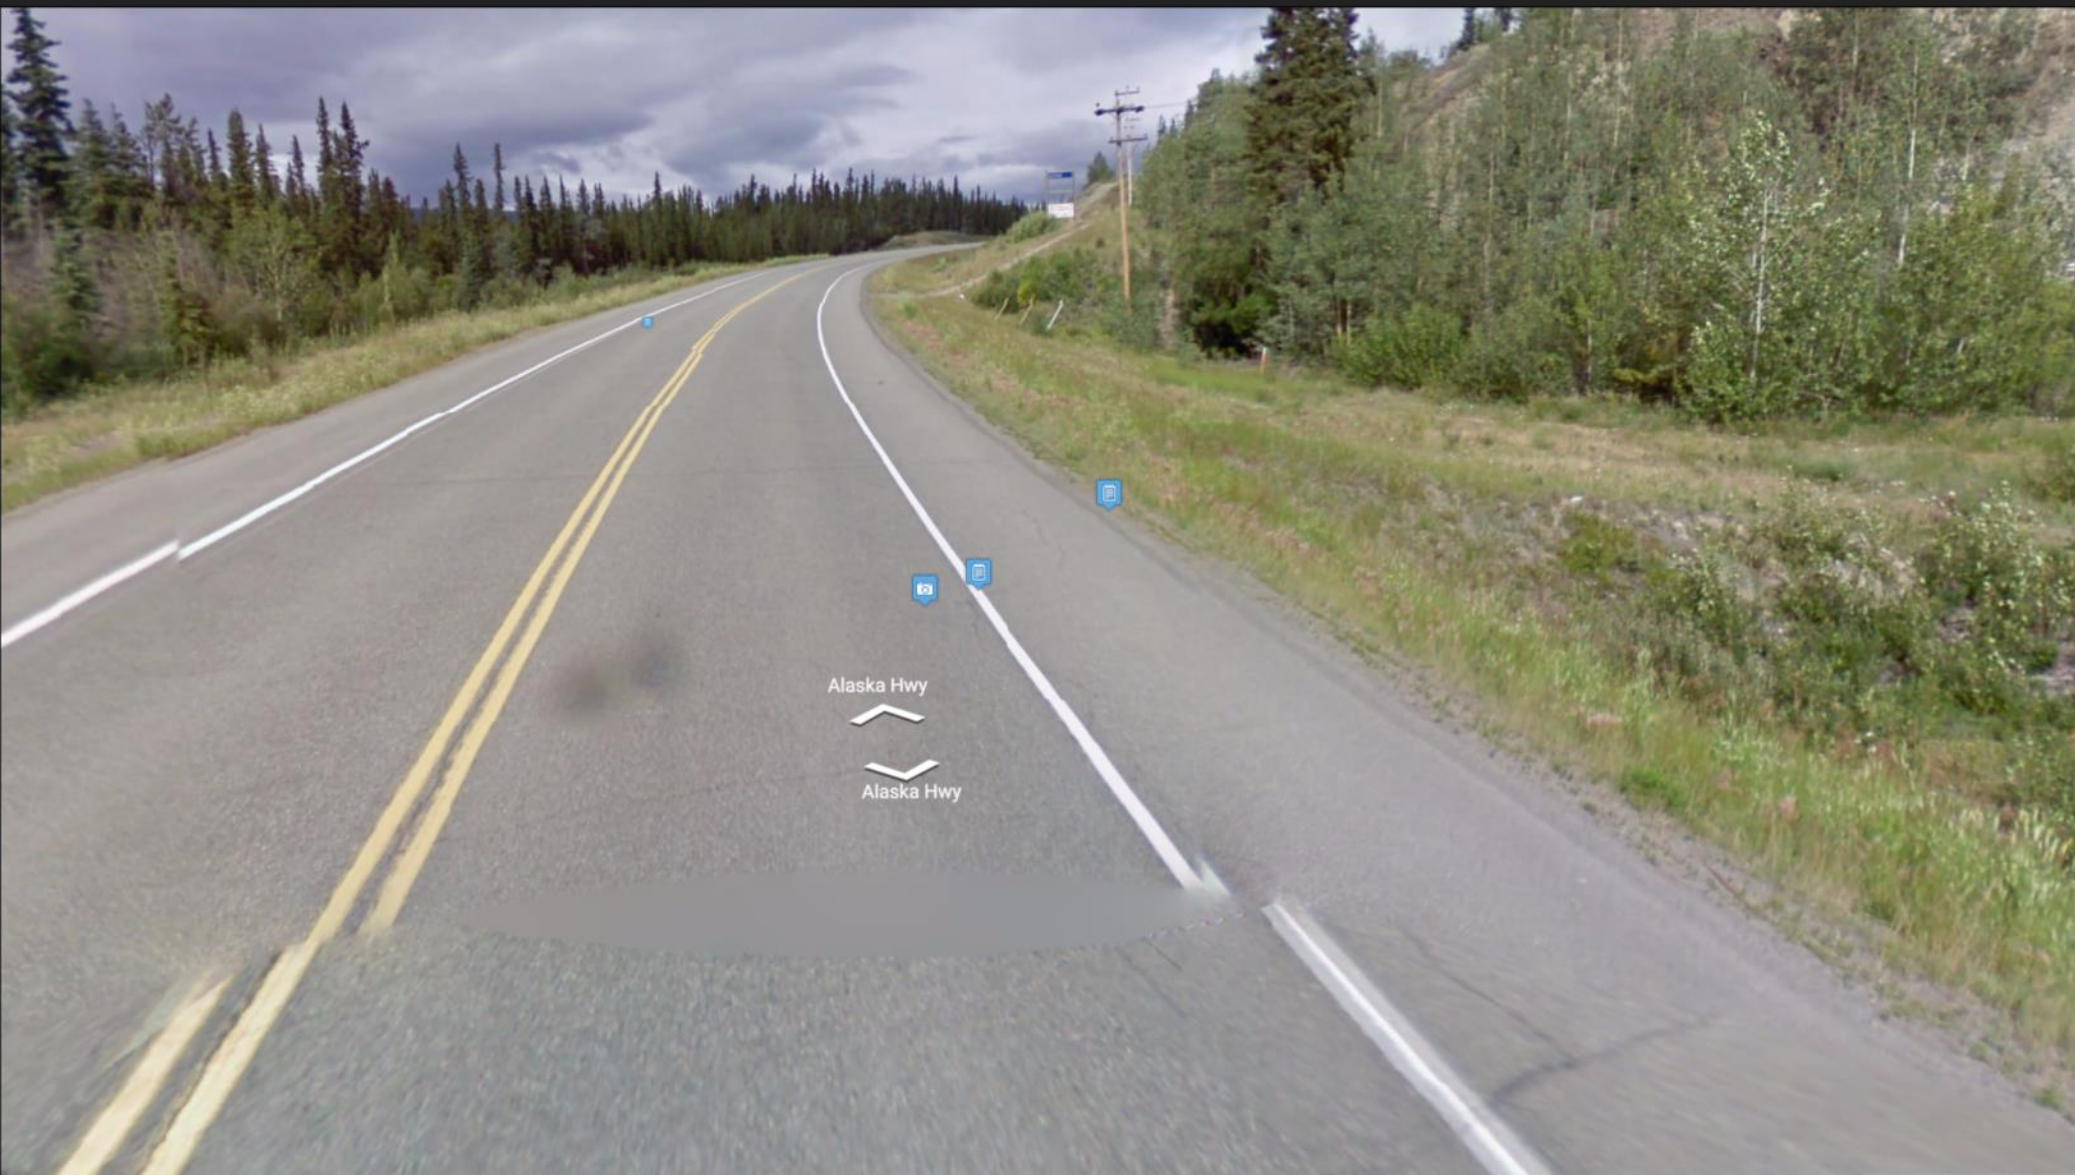
Alaska Highway breaker to Engelman

Audio Note
0:22
About 100 m north of the study segment for maybe six or 700 m side smoke looks deeper than it looks like 3 to 1 and it could be flat
08 March 2015, 01:02 PM

Audio Note
0:24
Detailed site line investigation at Castle Drive in Dawson reveals that there is insufficient site distance looking towards northbound traffic a long-term treatment would be to flatten the horizontal curve or find an alternative location for this intersection
08 March 2015, 01:17 PM

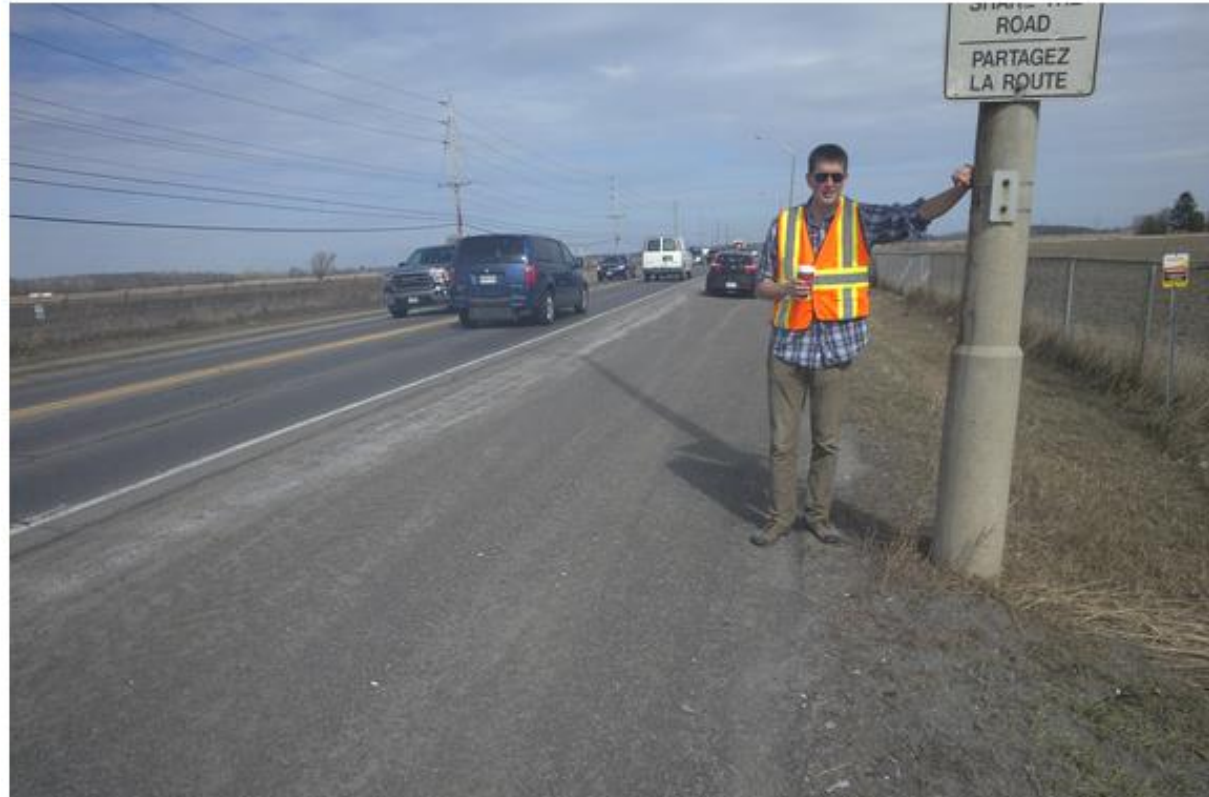
Poles on the east side of the highway are about 4 m or 4.5 m from the edge of the road.

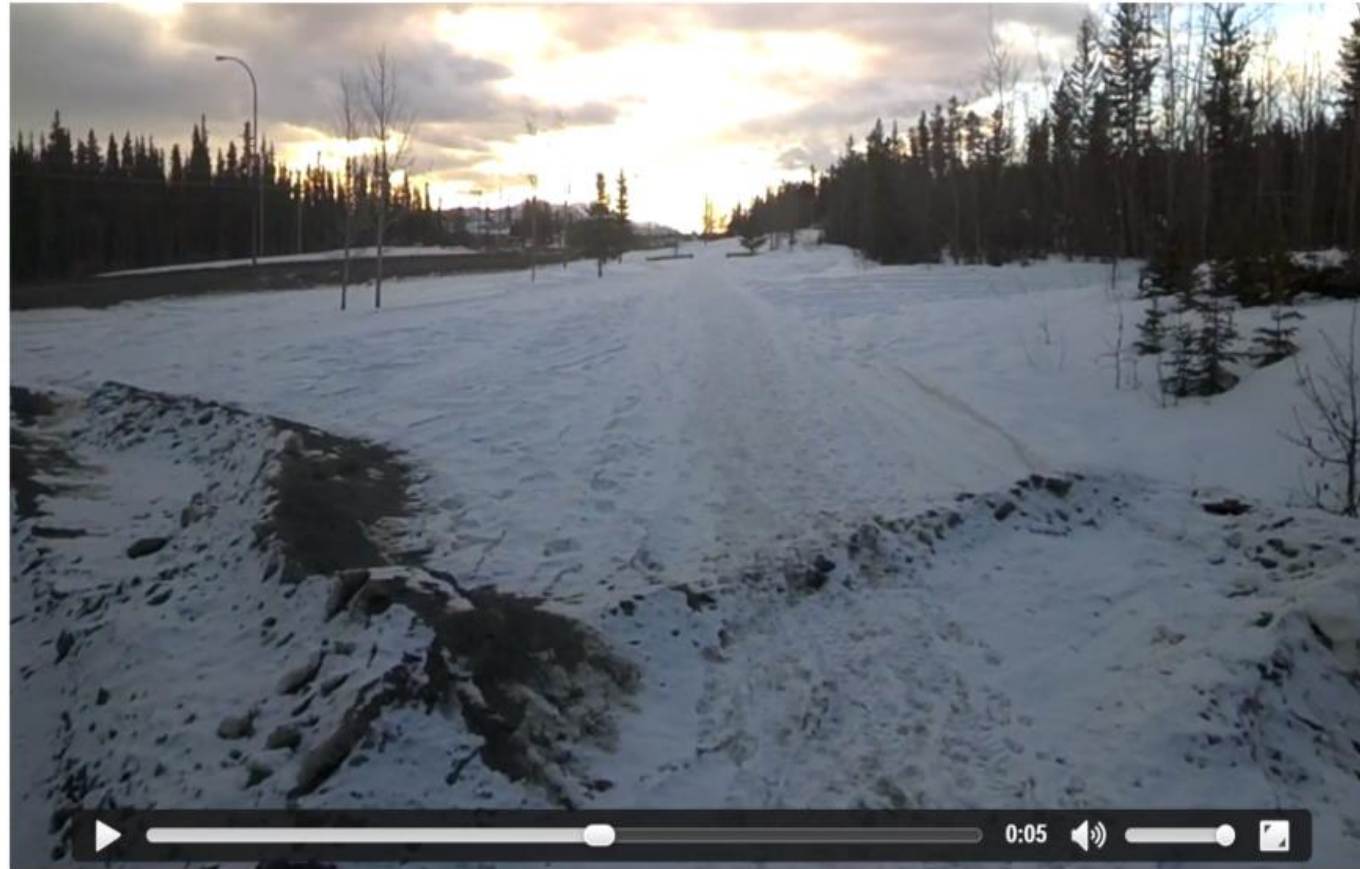
Multiuse trail that is your adjacent to Alaska Highway appears to have a significant use
