GORDON DR / CASORSO RD INTERSECTION CYCLING IMPROVEMENTS

OUTLINE

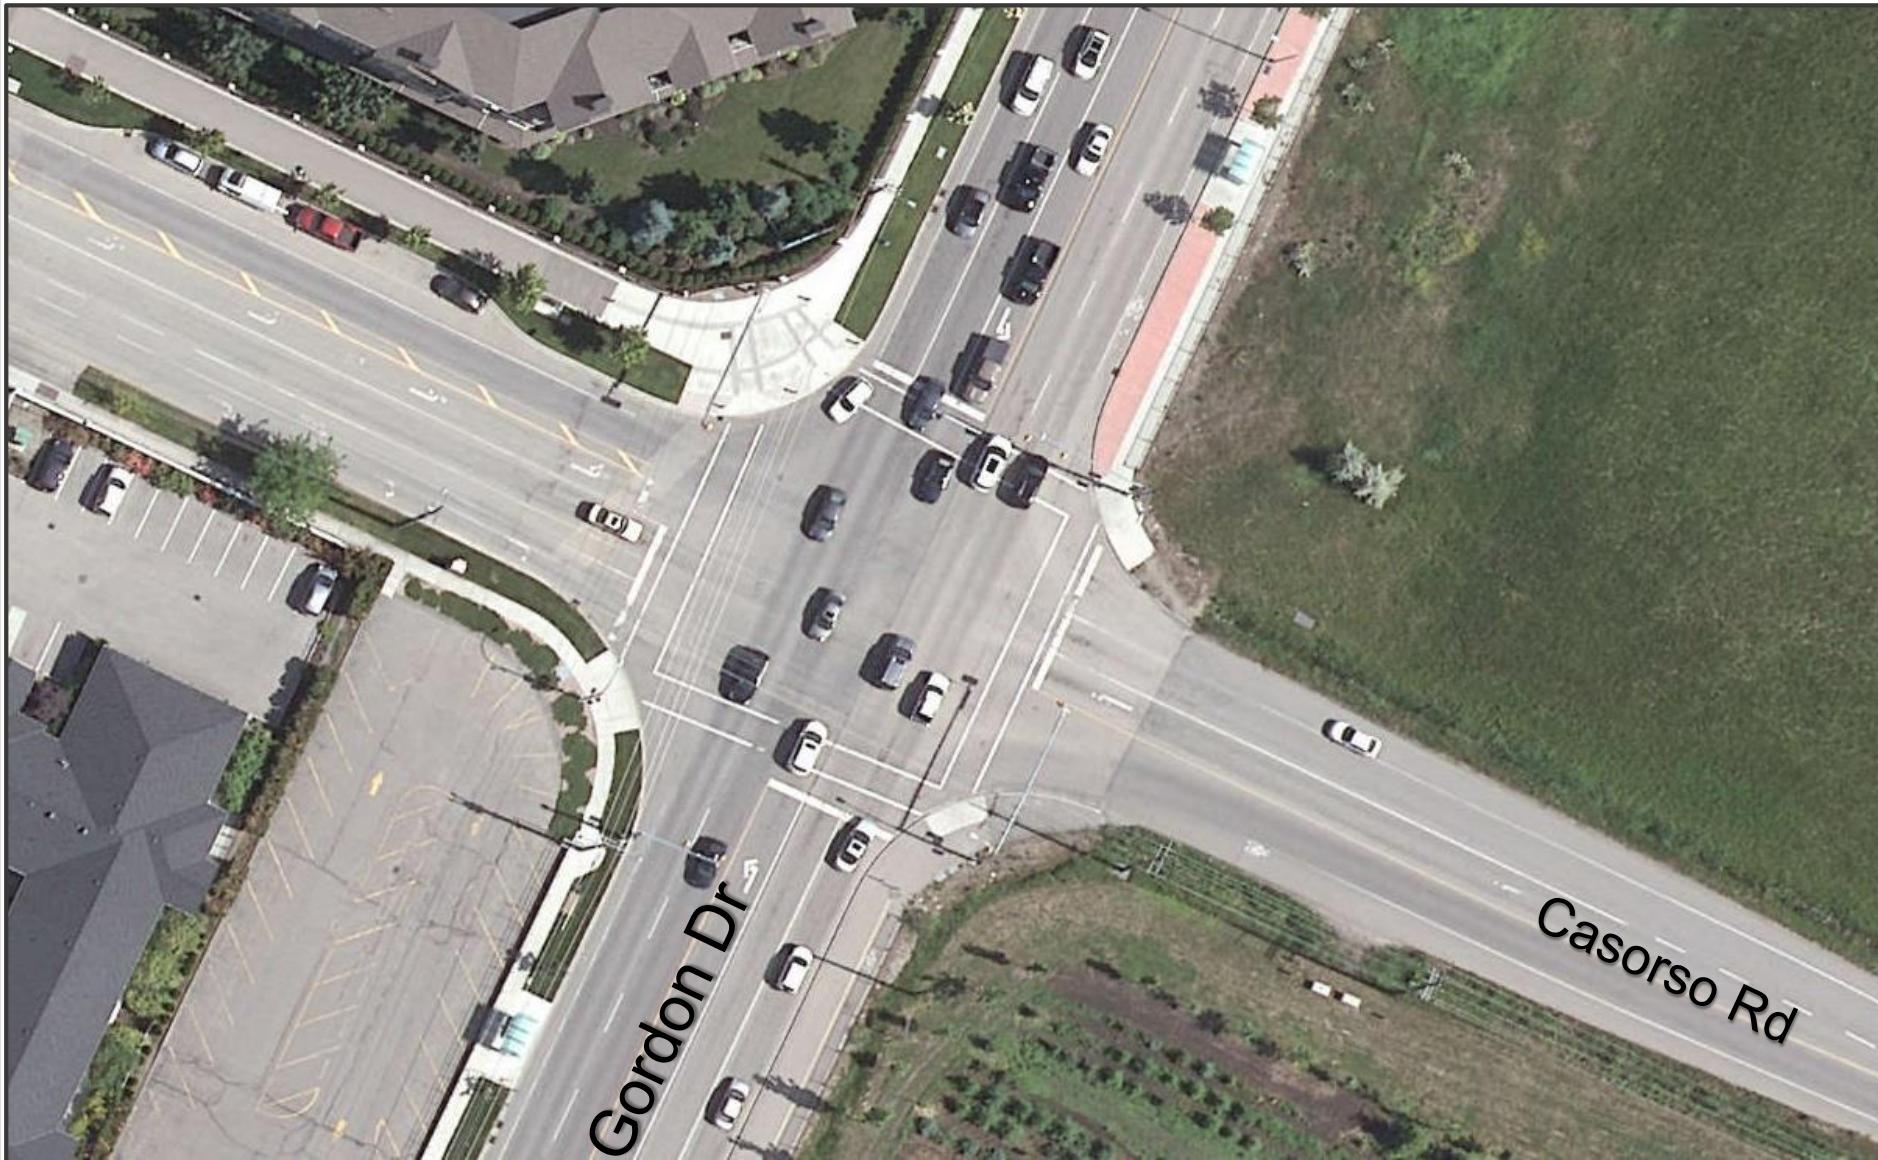
INTERSECTION

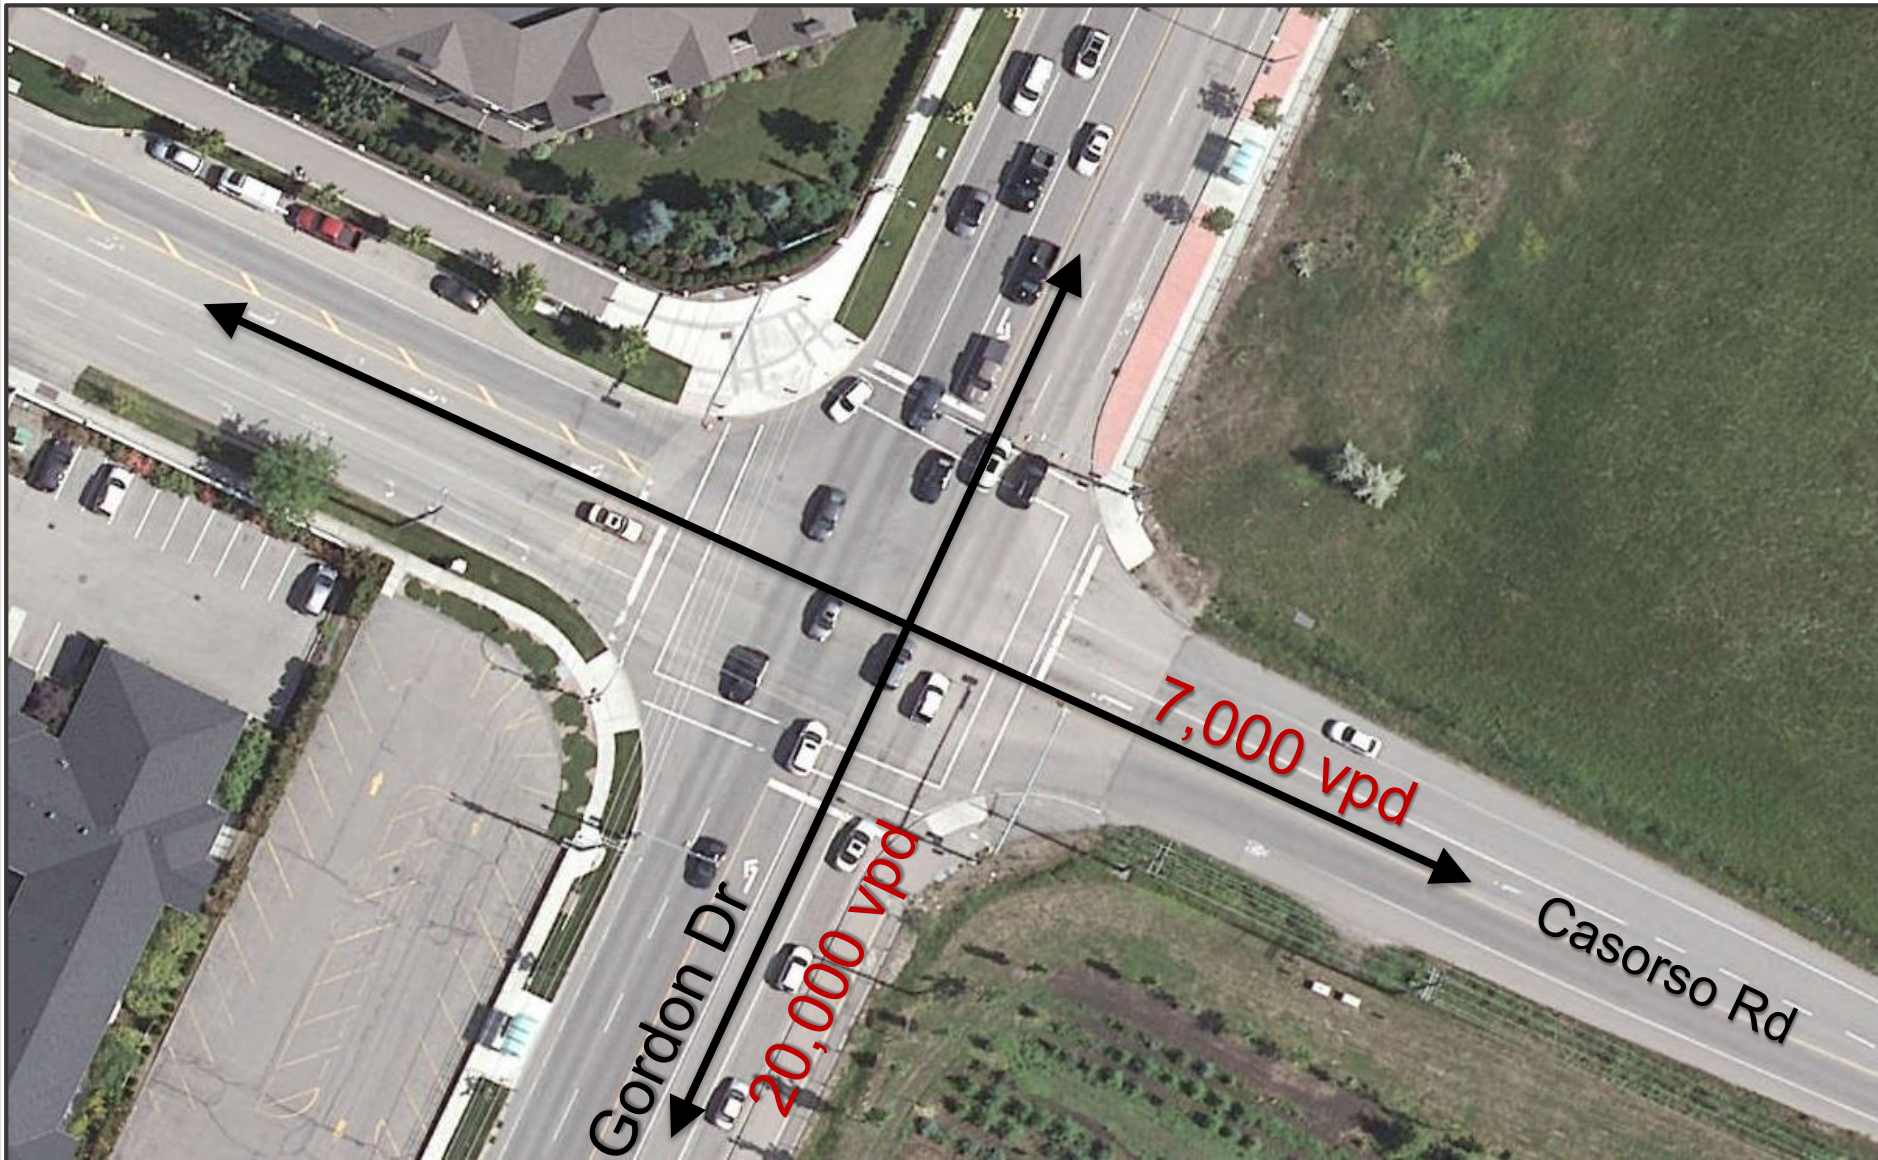
INTERSECTION – VEHICLE TRAFFIC

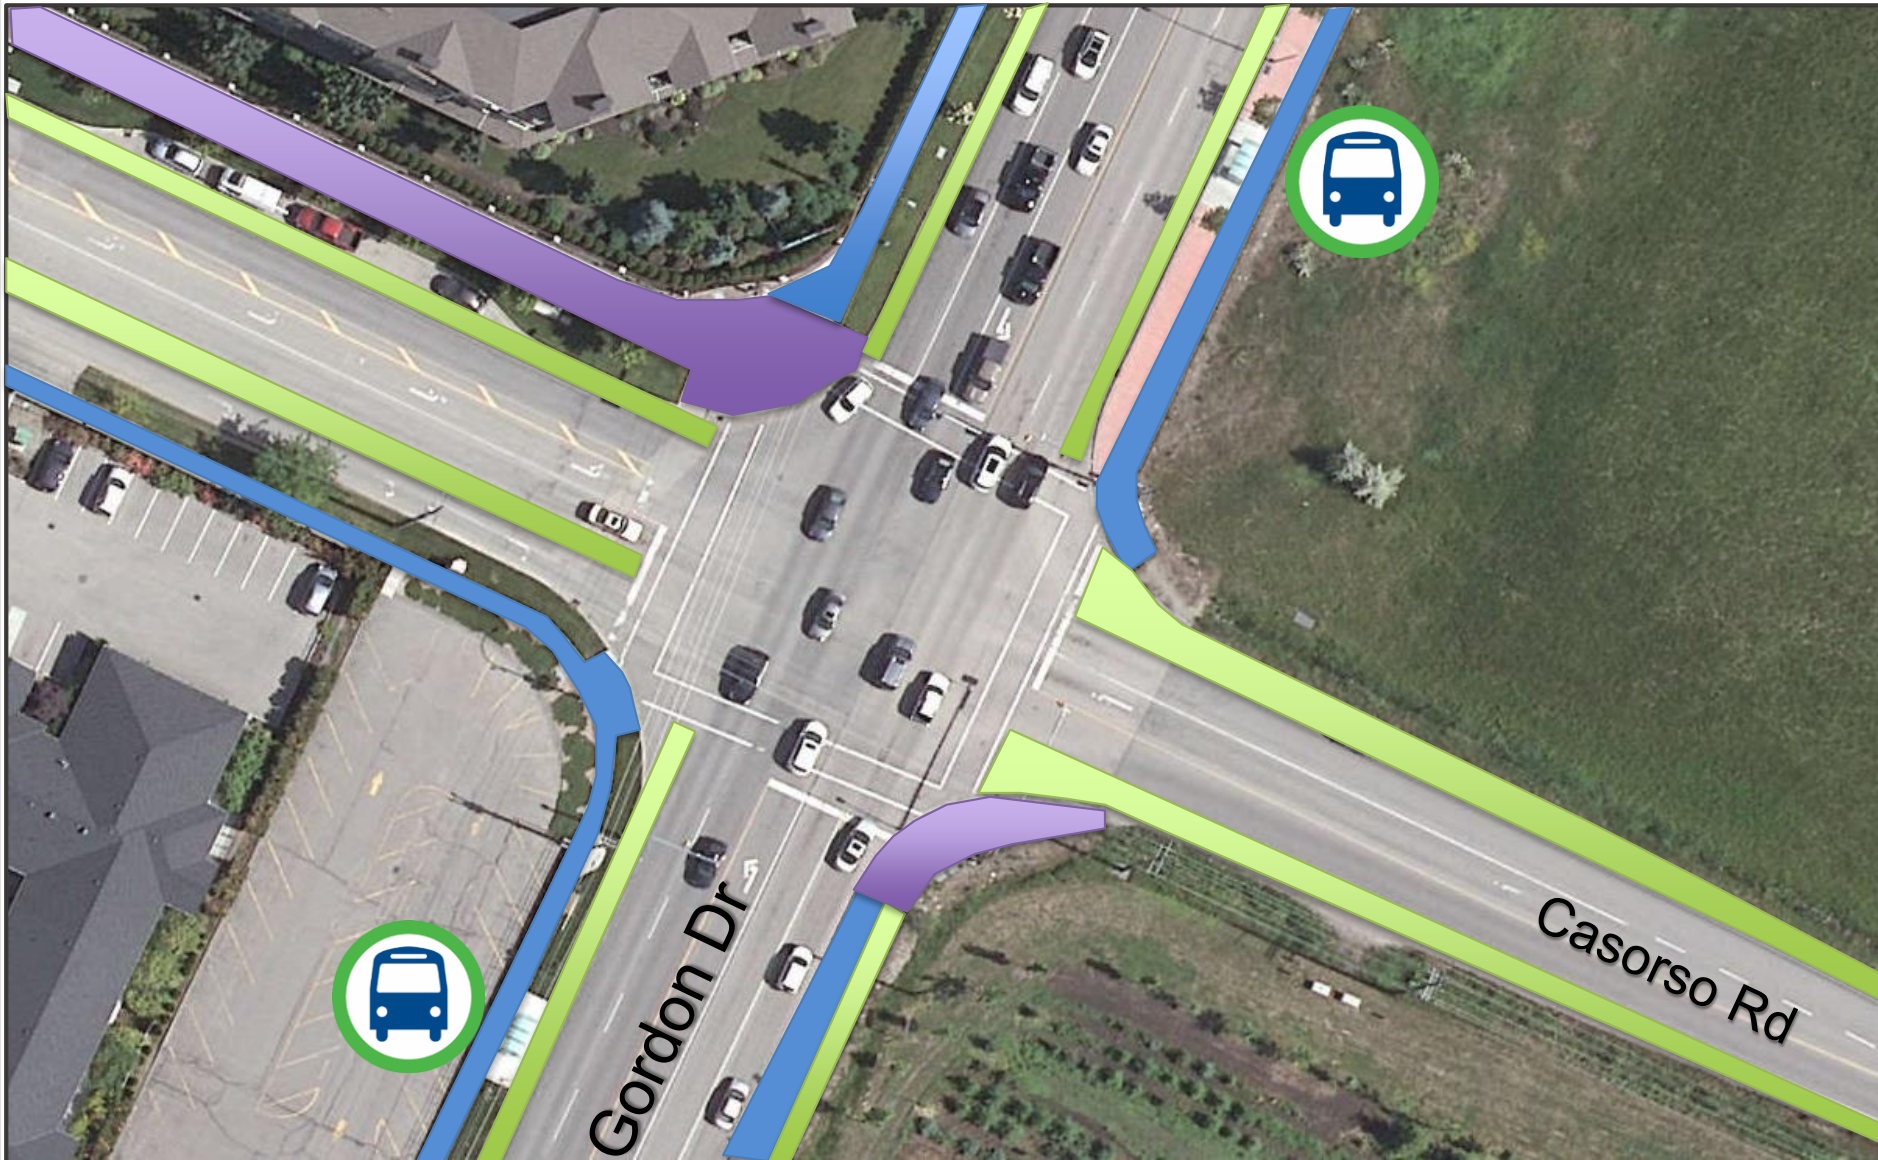
INTERSECTION – FACILITIES

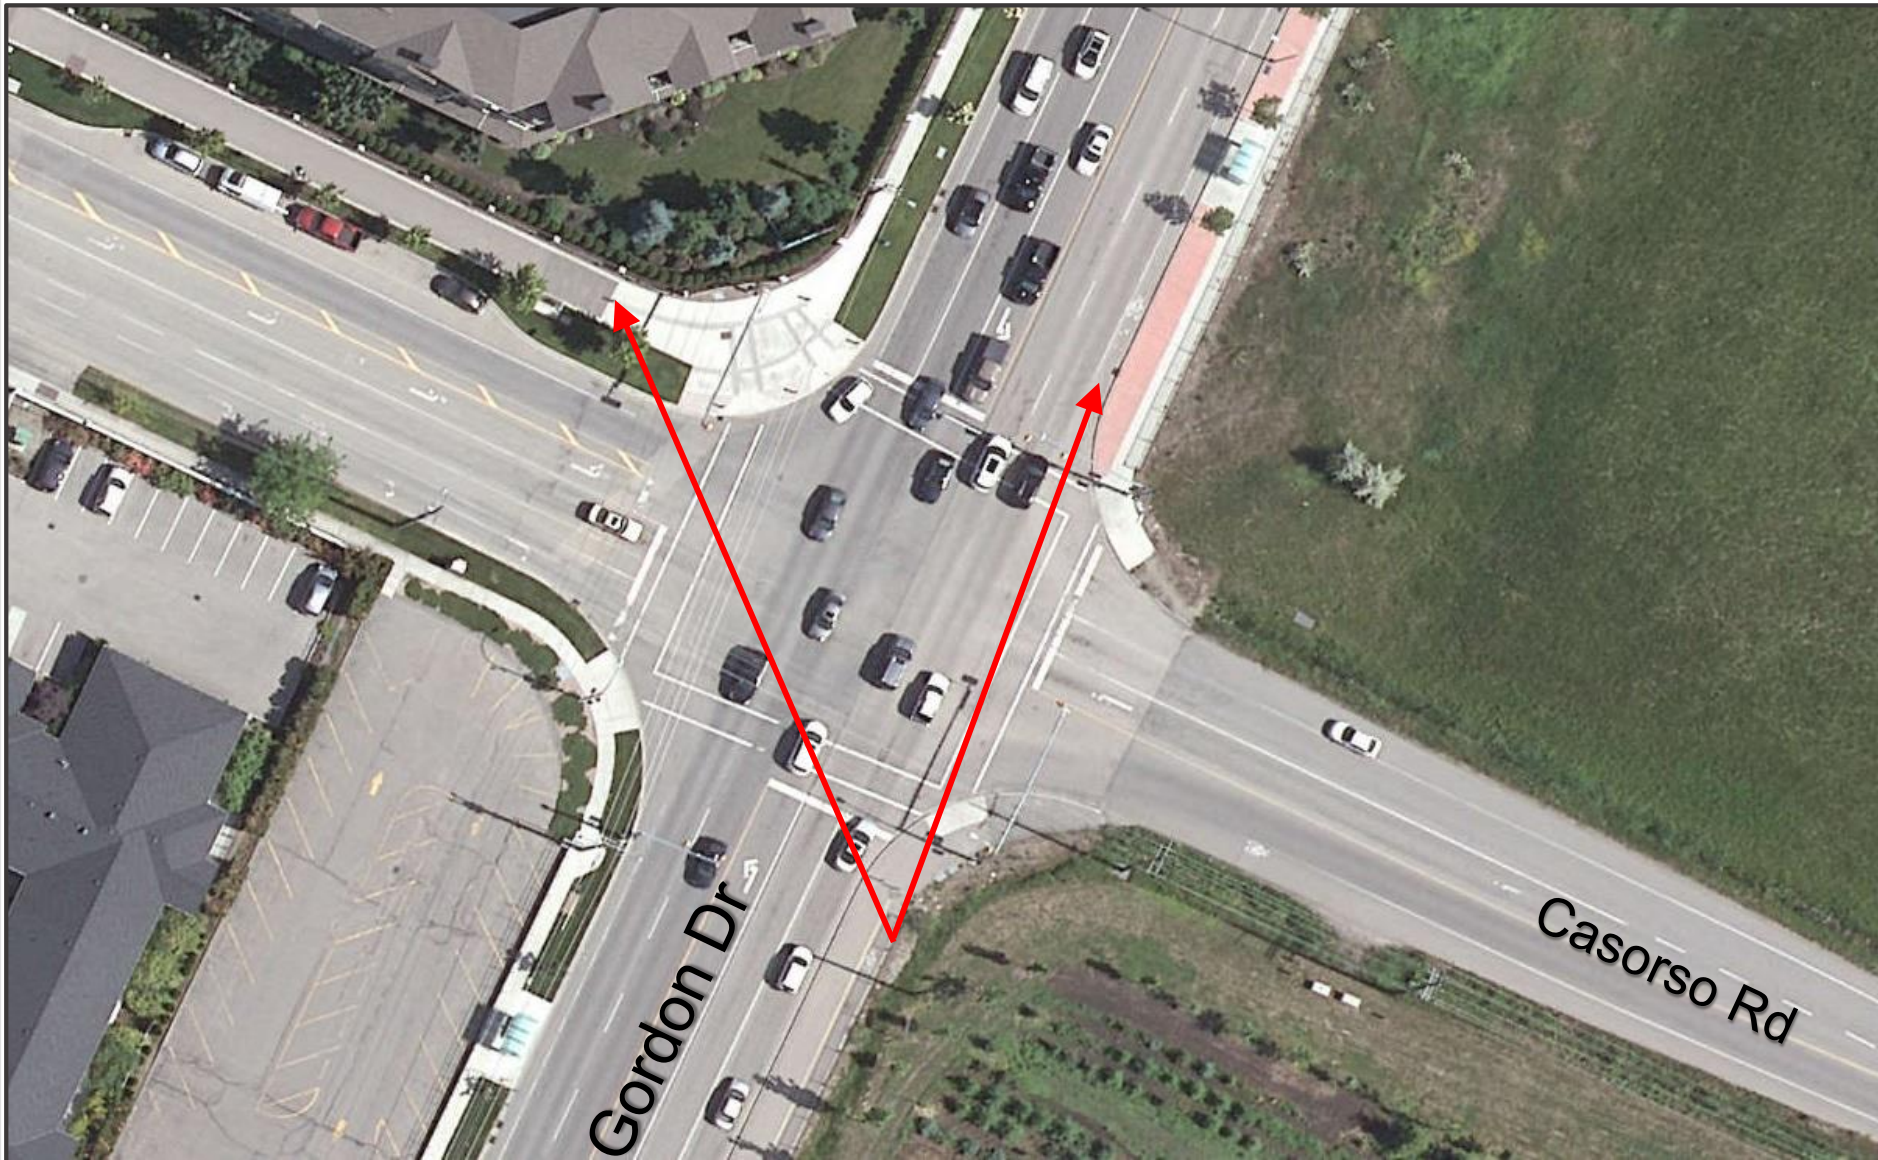
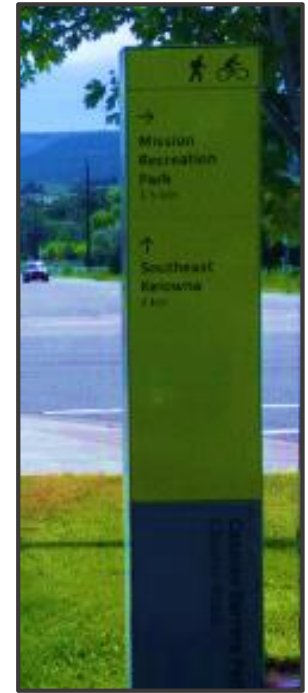
INTERSECTION - TRANSITION

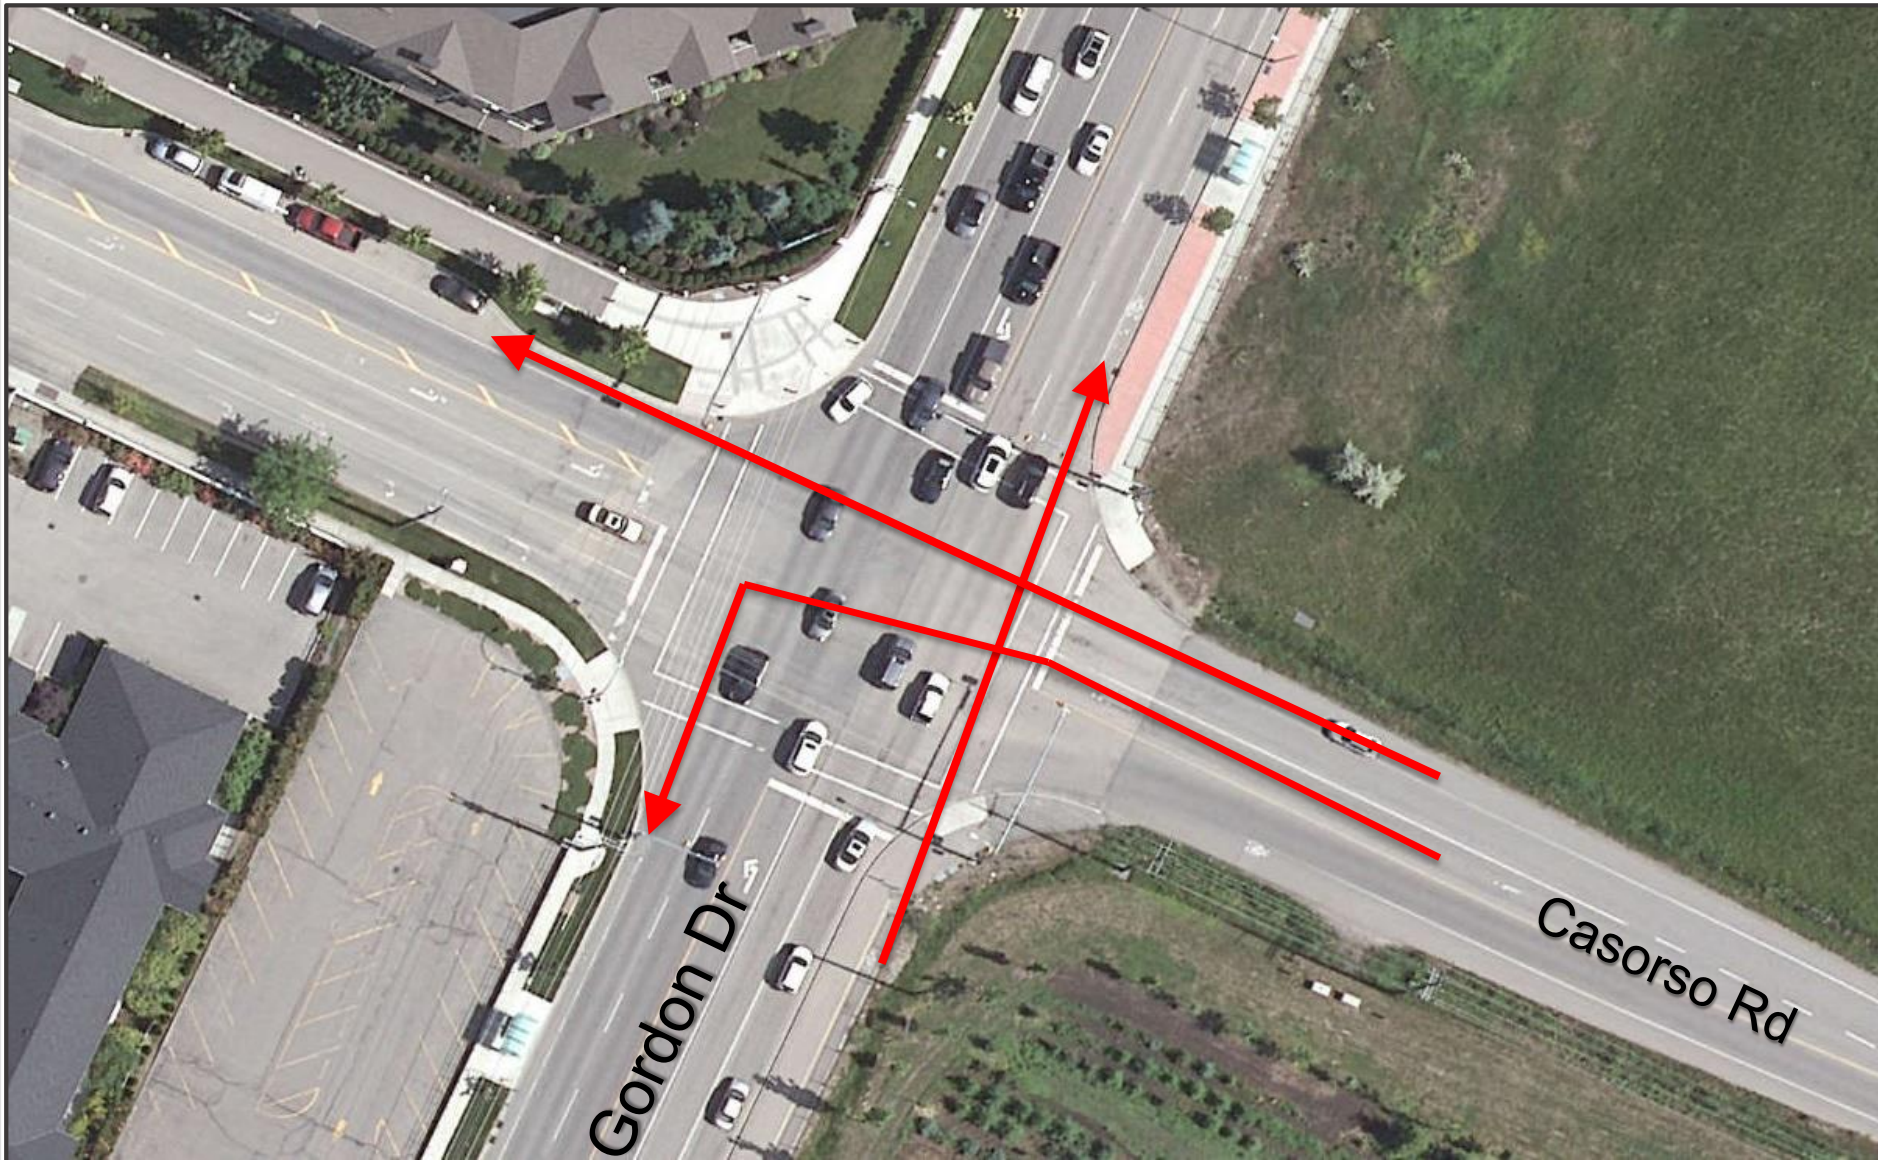
OBSERVATIONS – CONFIDENT CYCLISTS

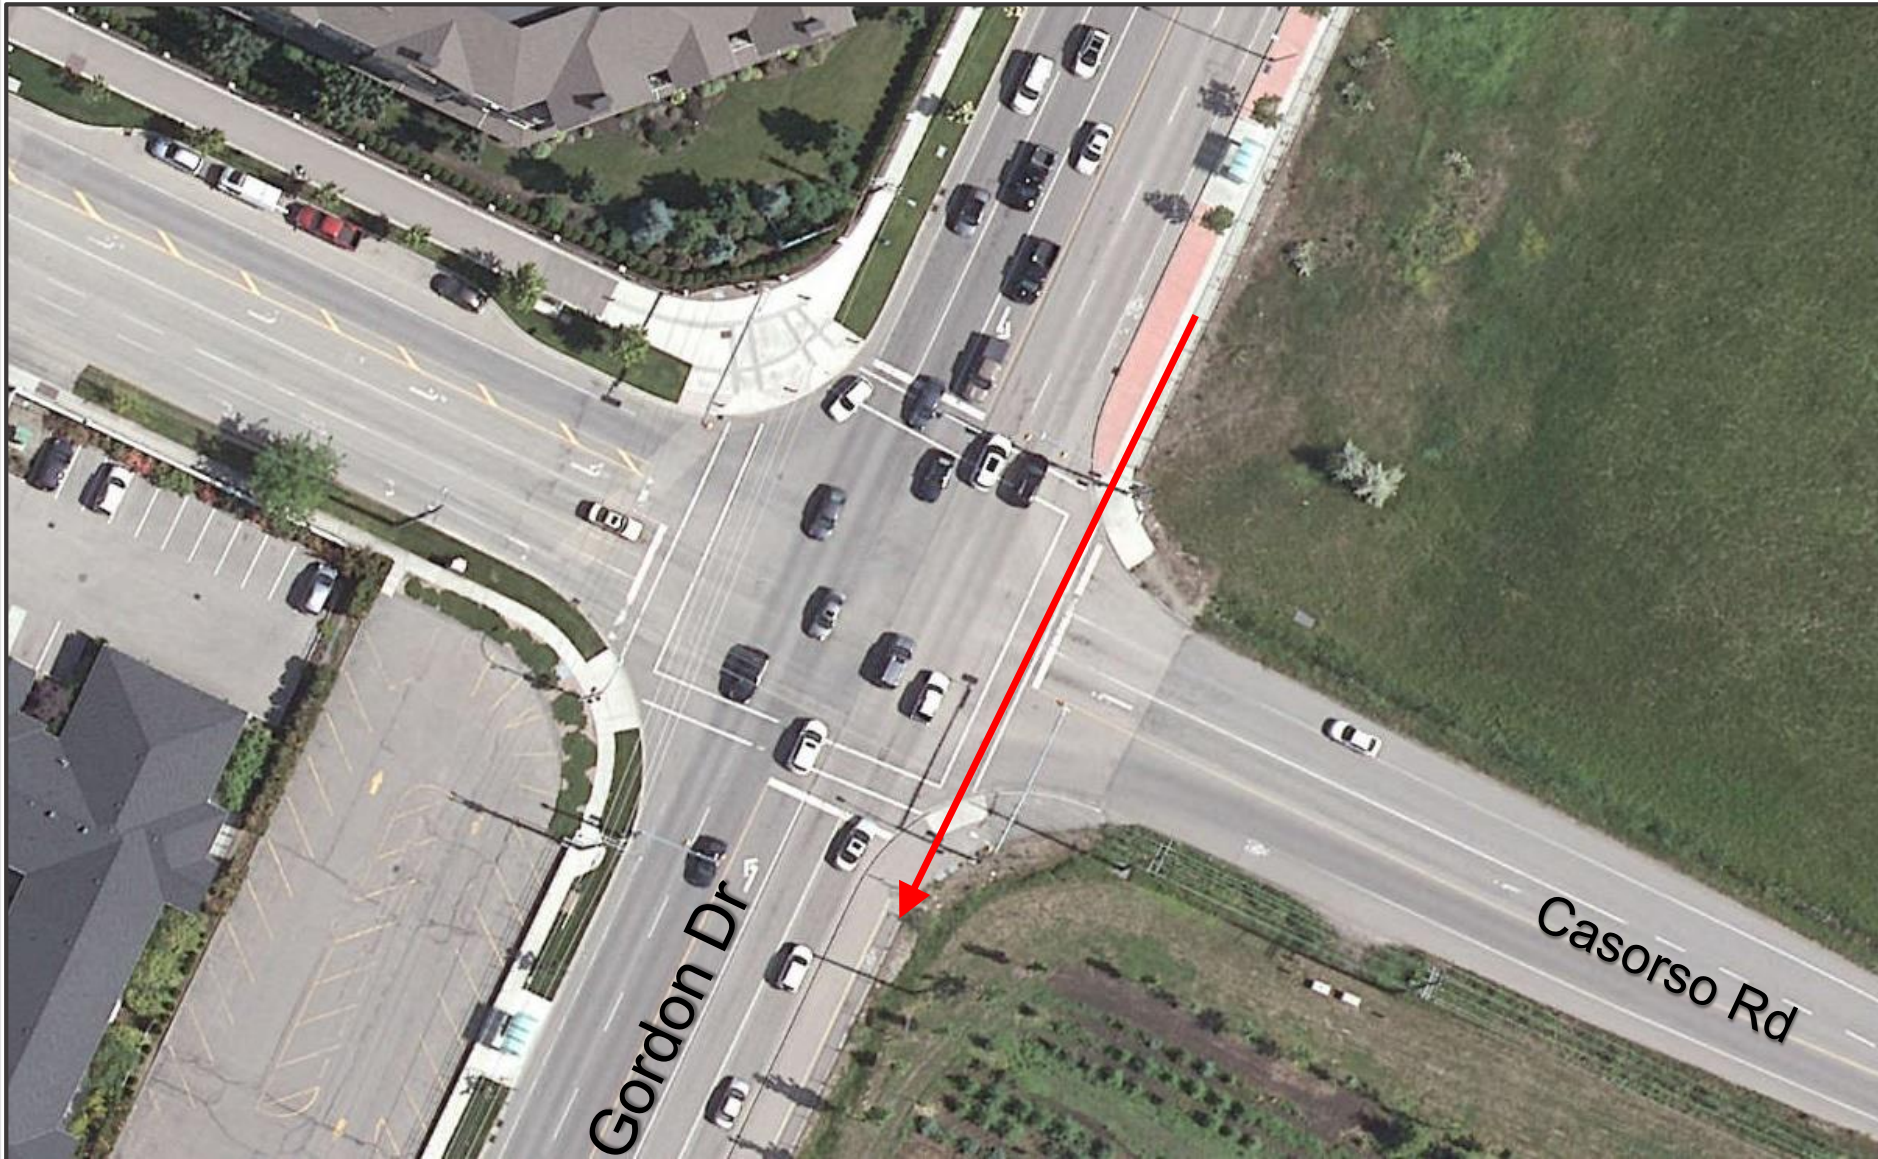
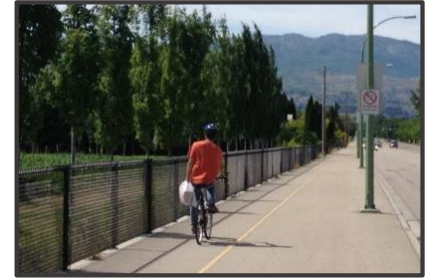
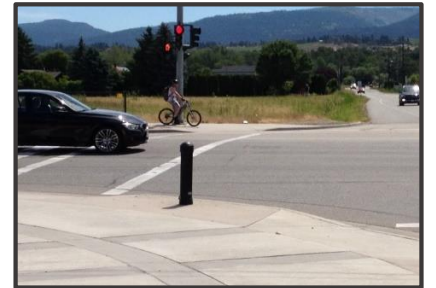
OBSERVATIONS – NON-CONFIDENT CYCLISTS

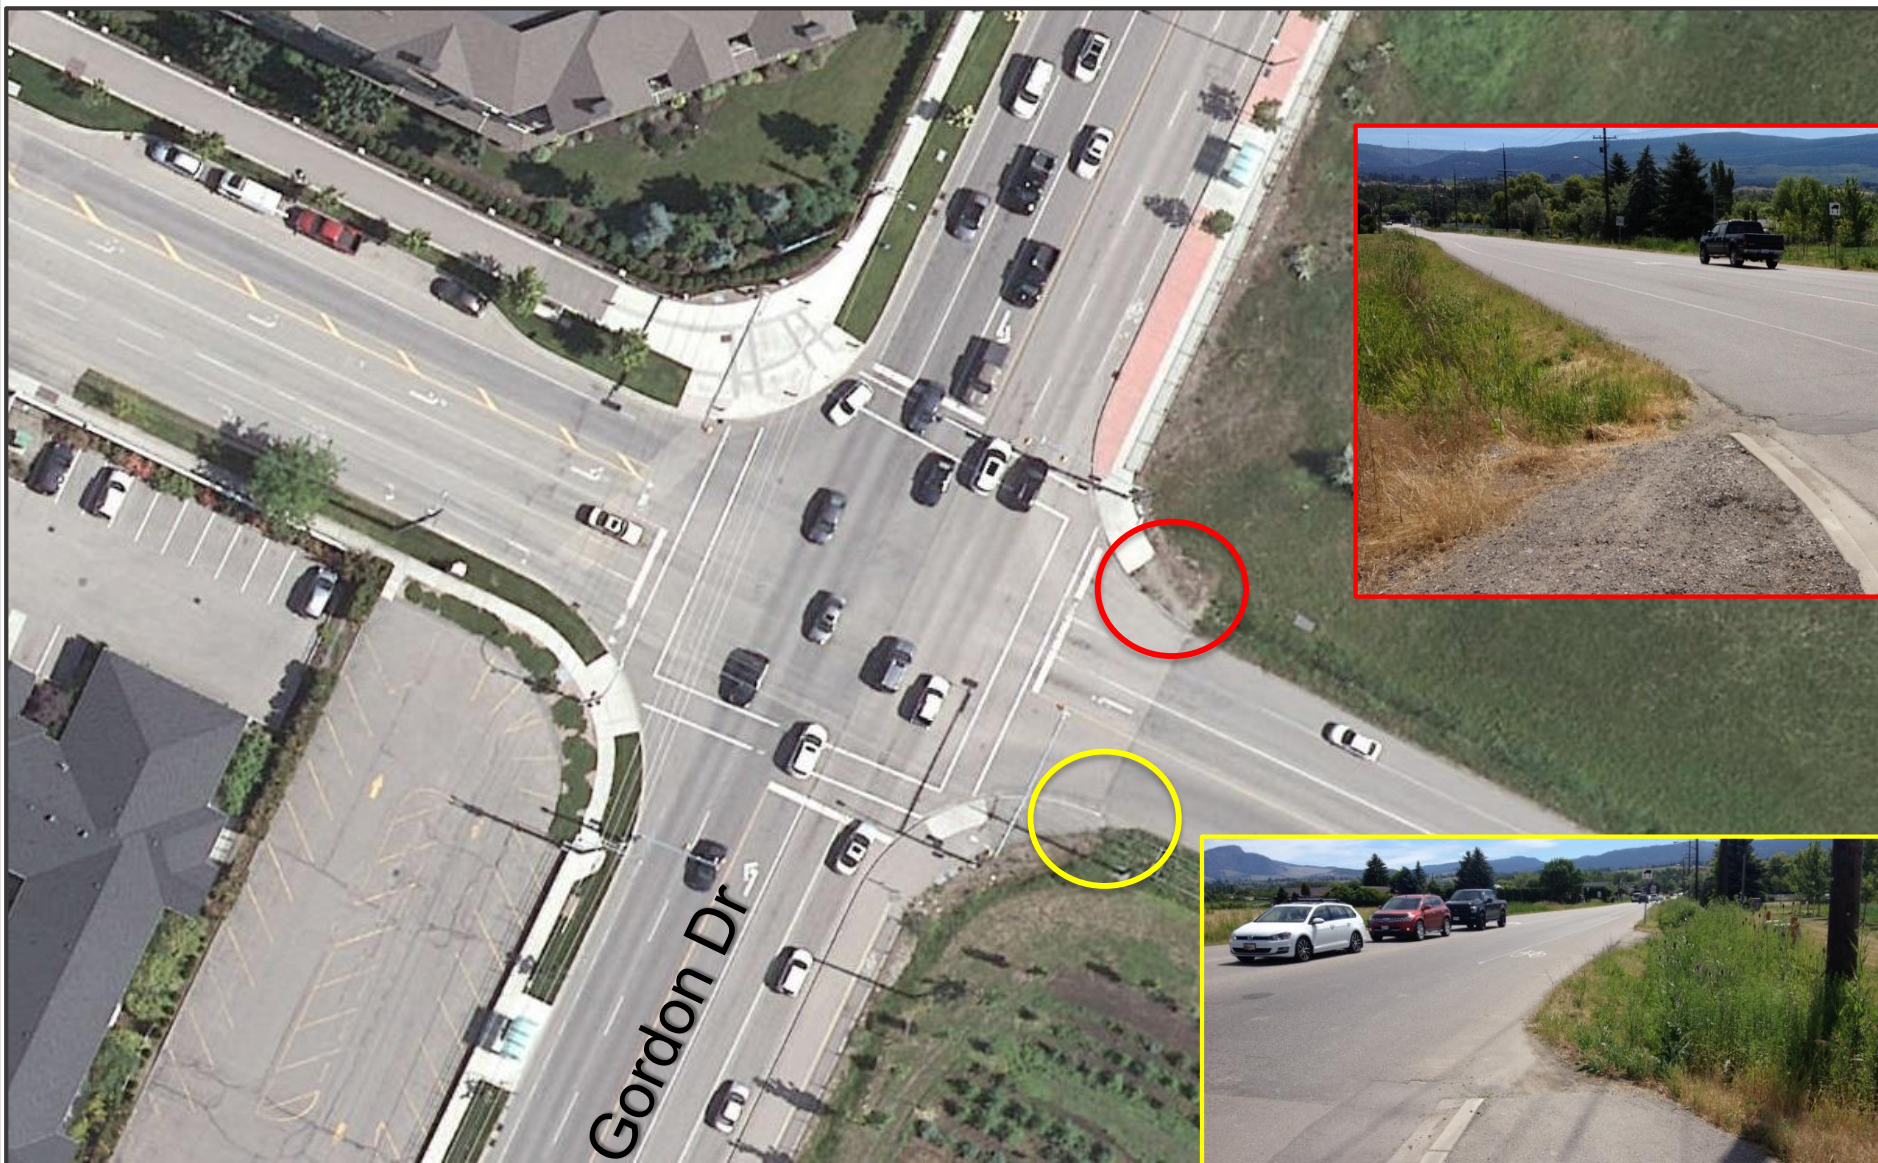
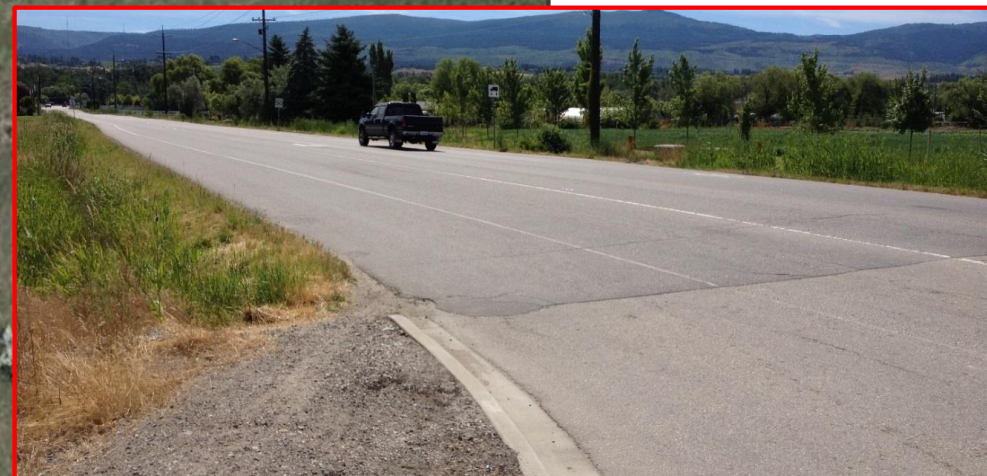
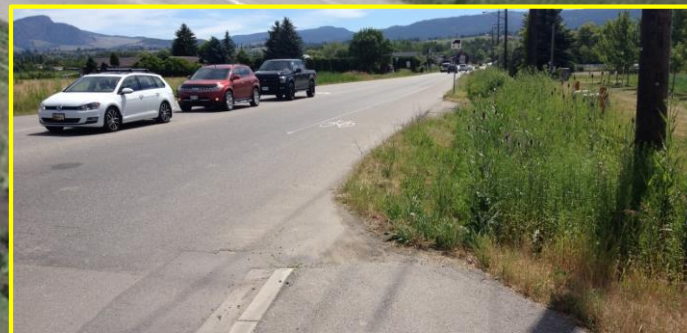
OBSERVATIONS – BIKE RAMPS

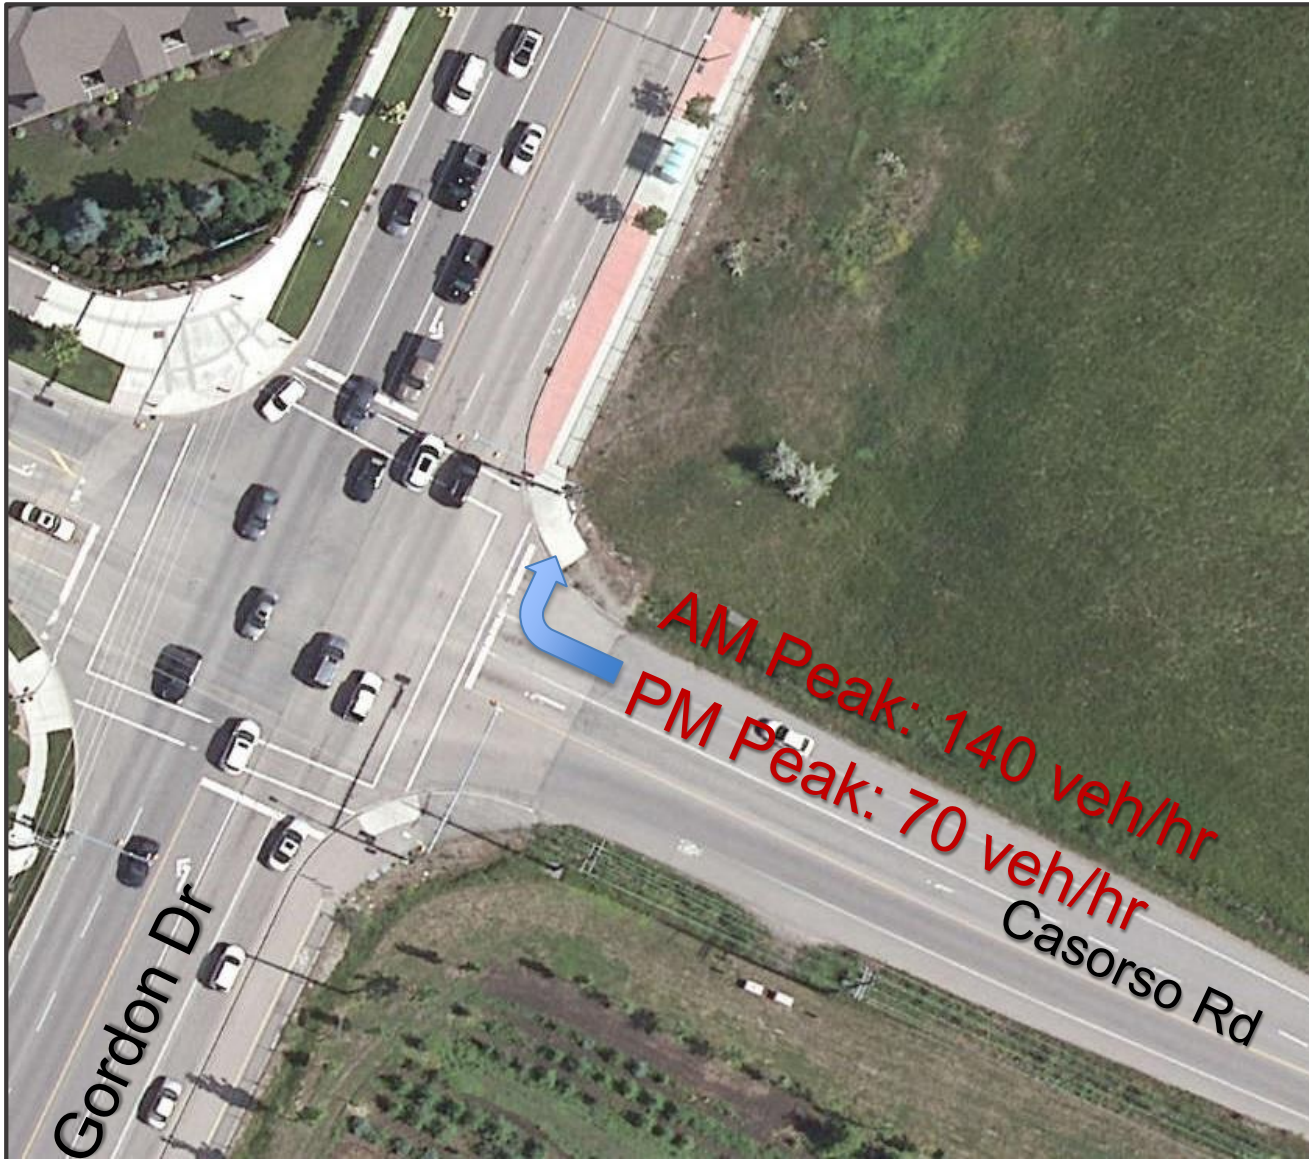
OPERATIONS – WITH RIGHT-TURN LANE

- Minor Improvements to Delay and Queue Lengths

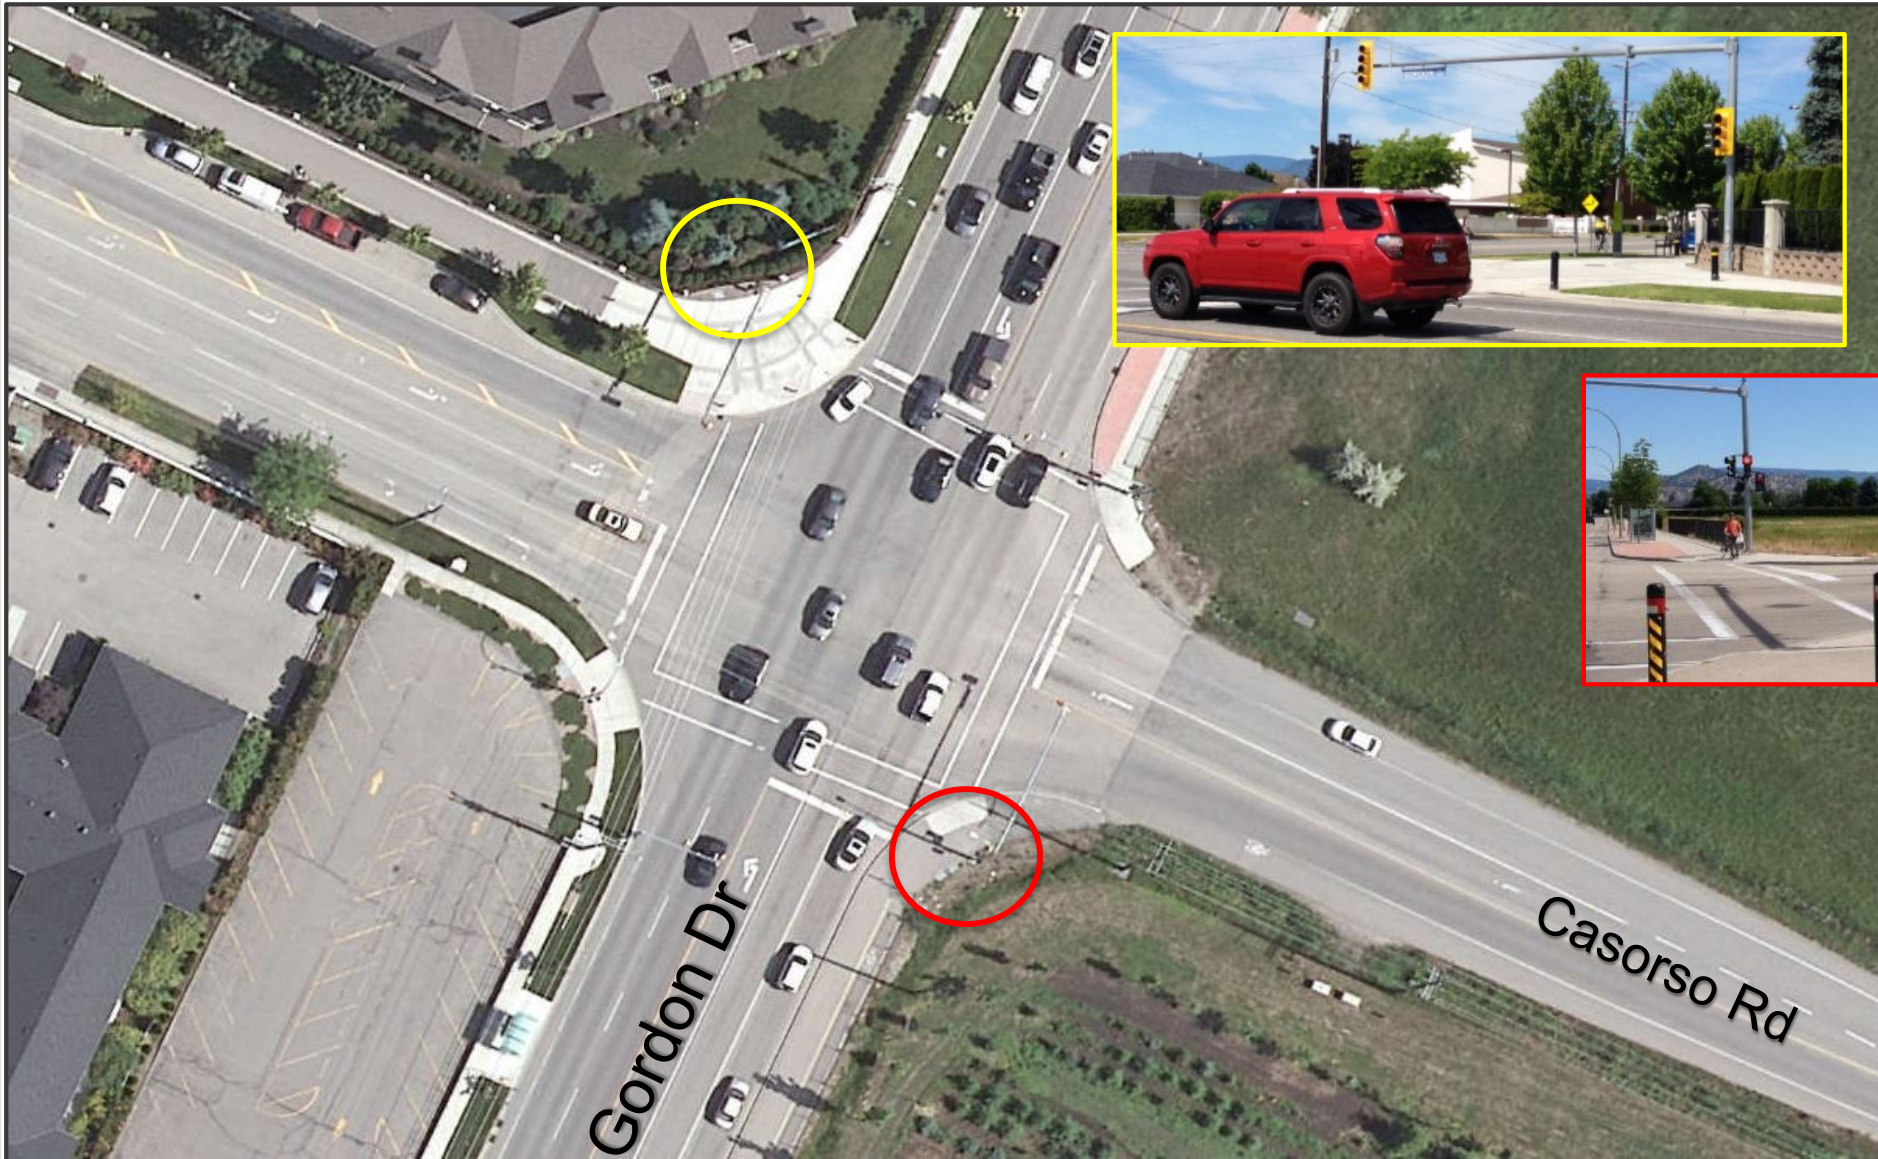
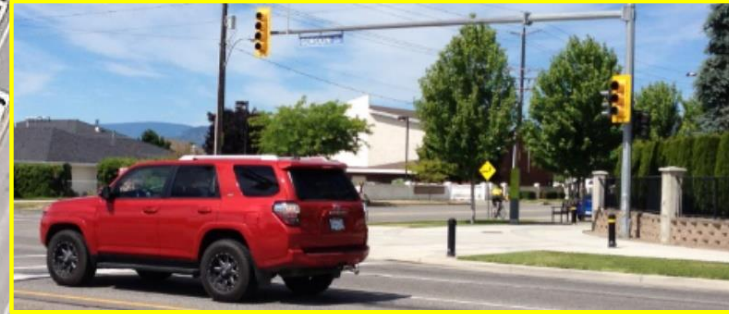
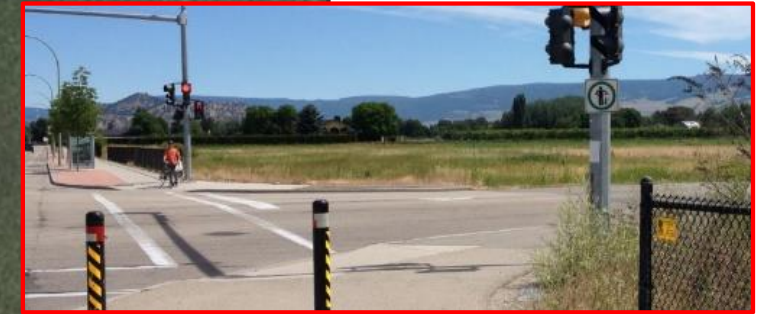
CYCLIST SIGNAL TIMING & ACTUATION

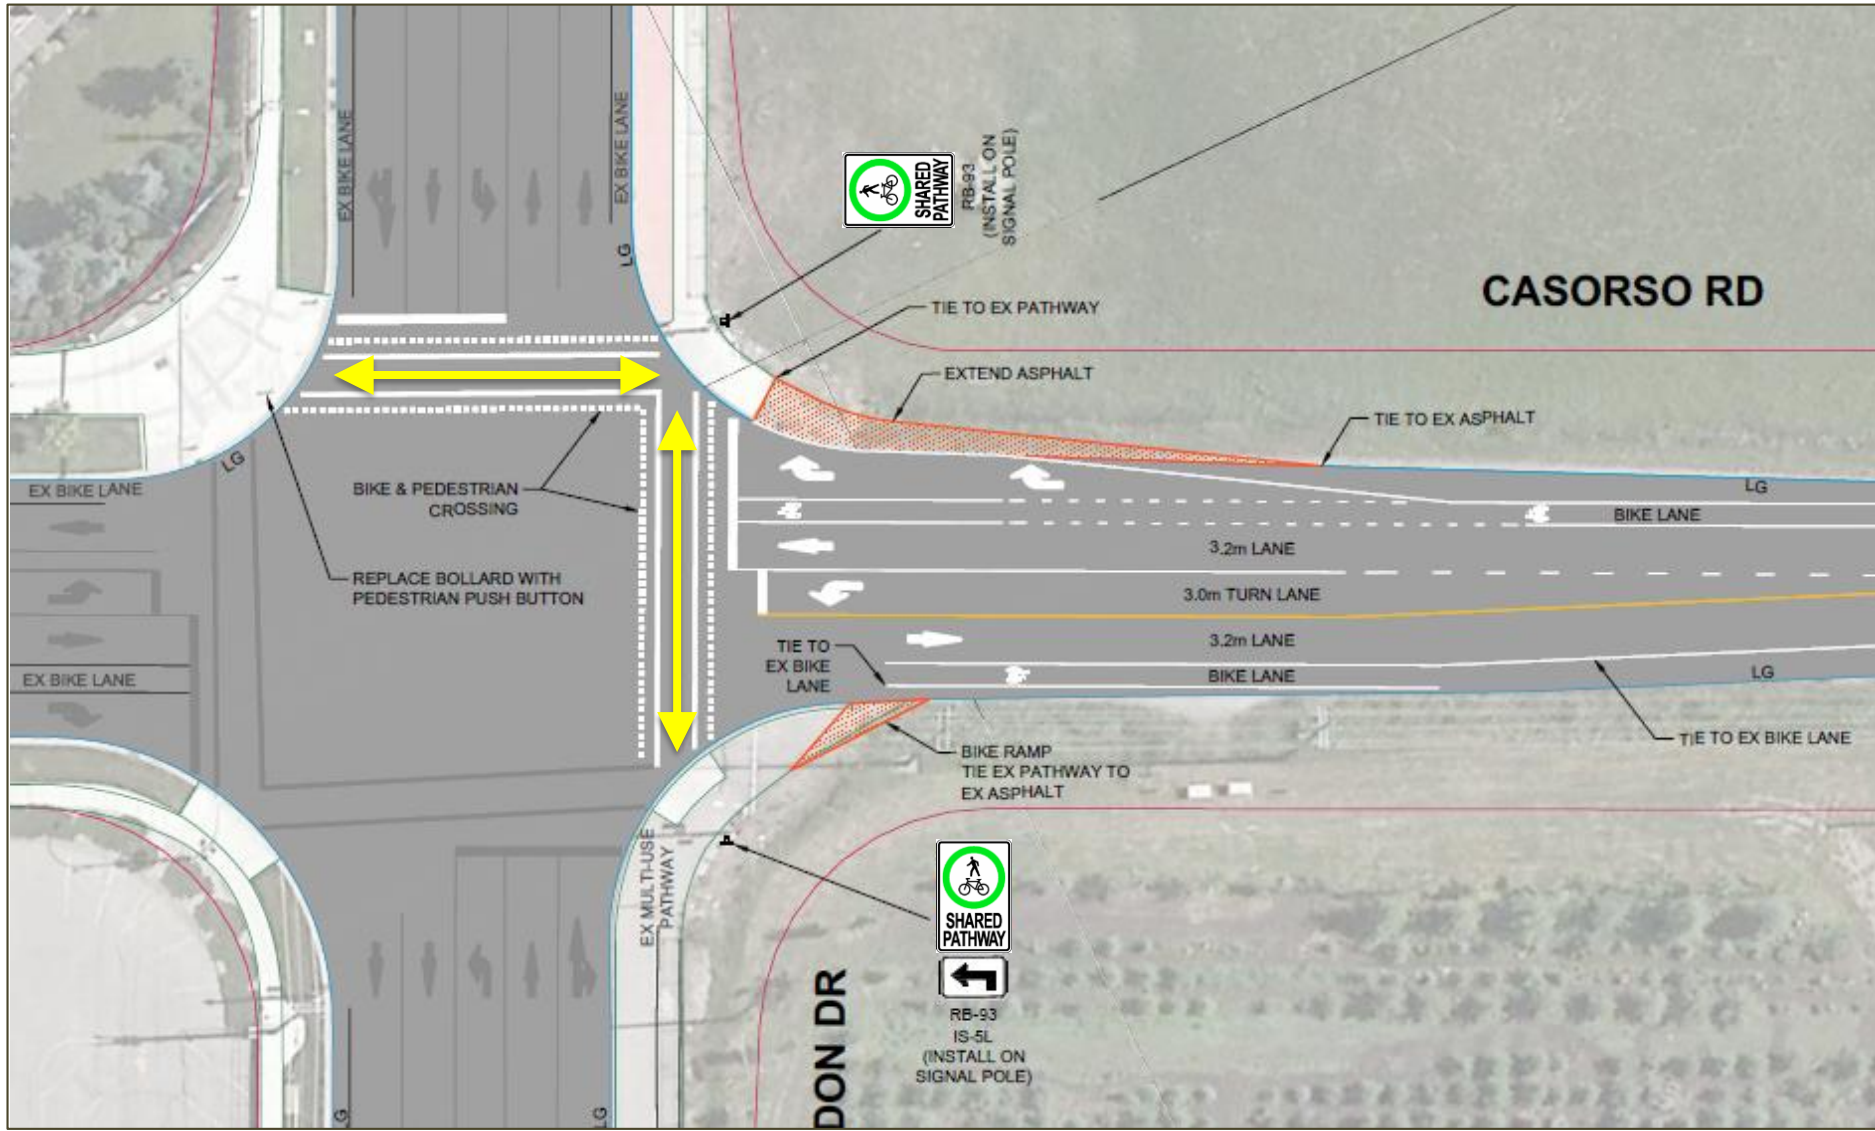
DESIGN – SHARED CROSSWALKS
