GORDON DR / CASORSO RD INTERSECTION CYCLING IMPROVEMENTS

OUTLINE

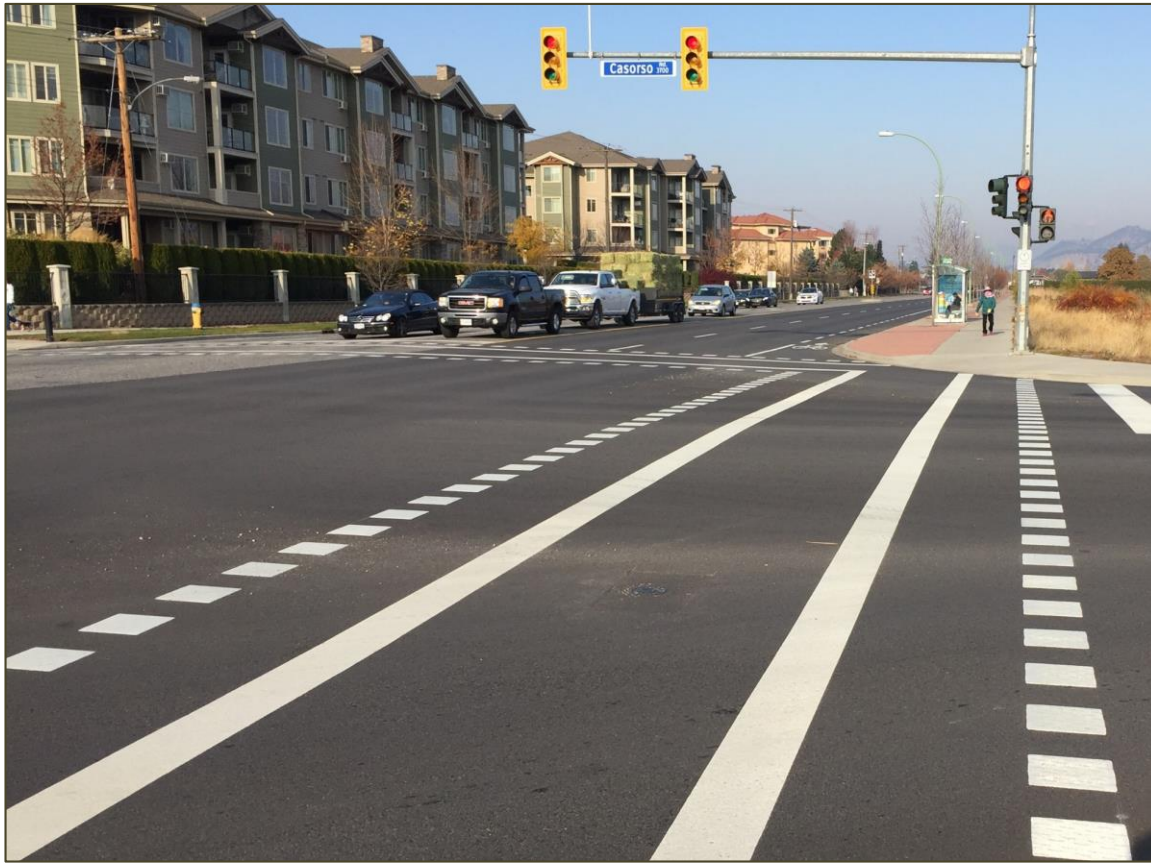
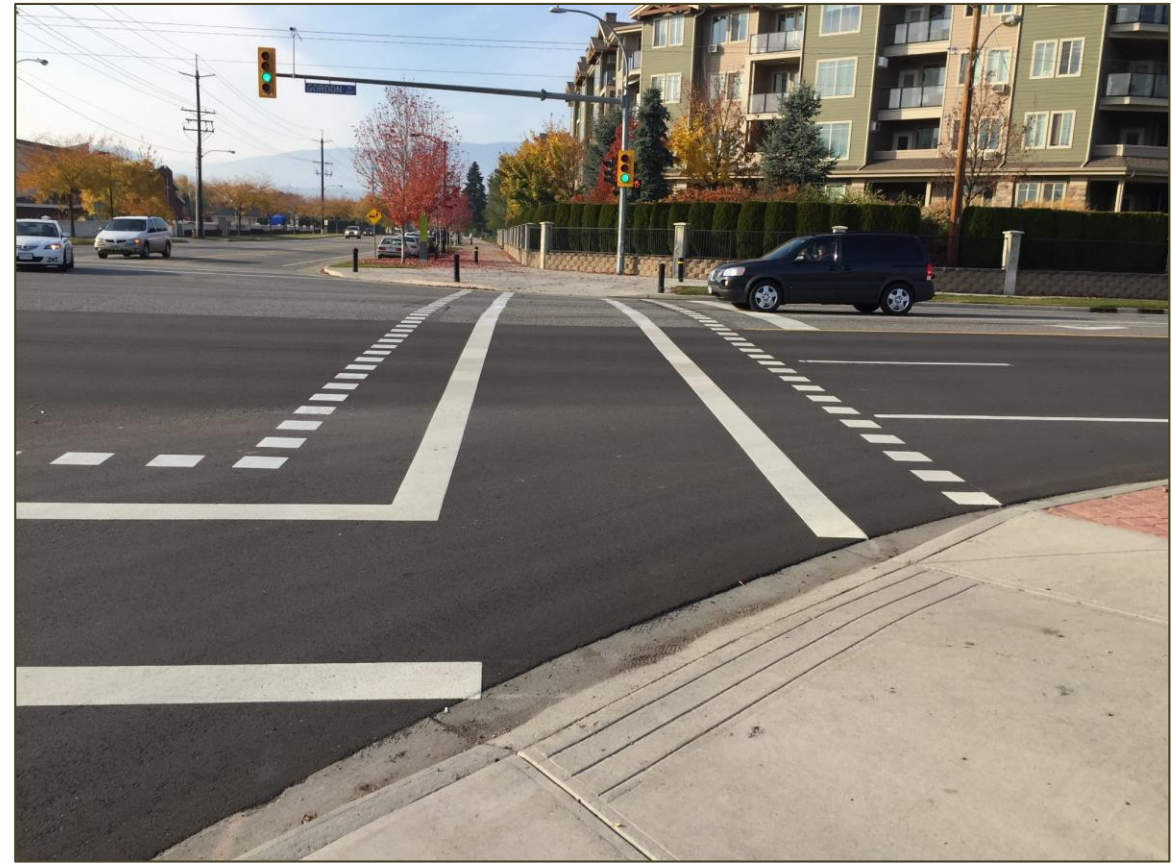
DESIGN – SHARED CROSSWALKS

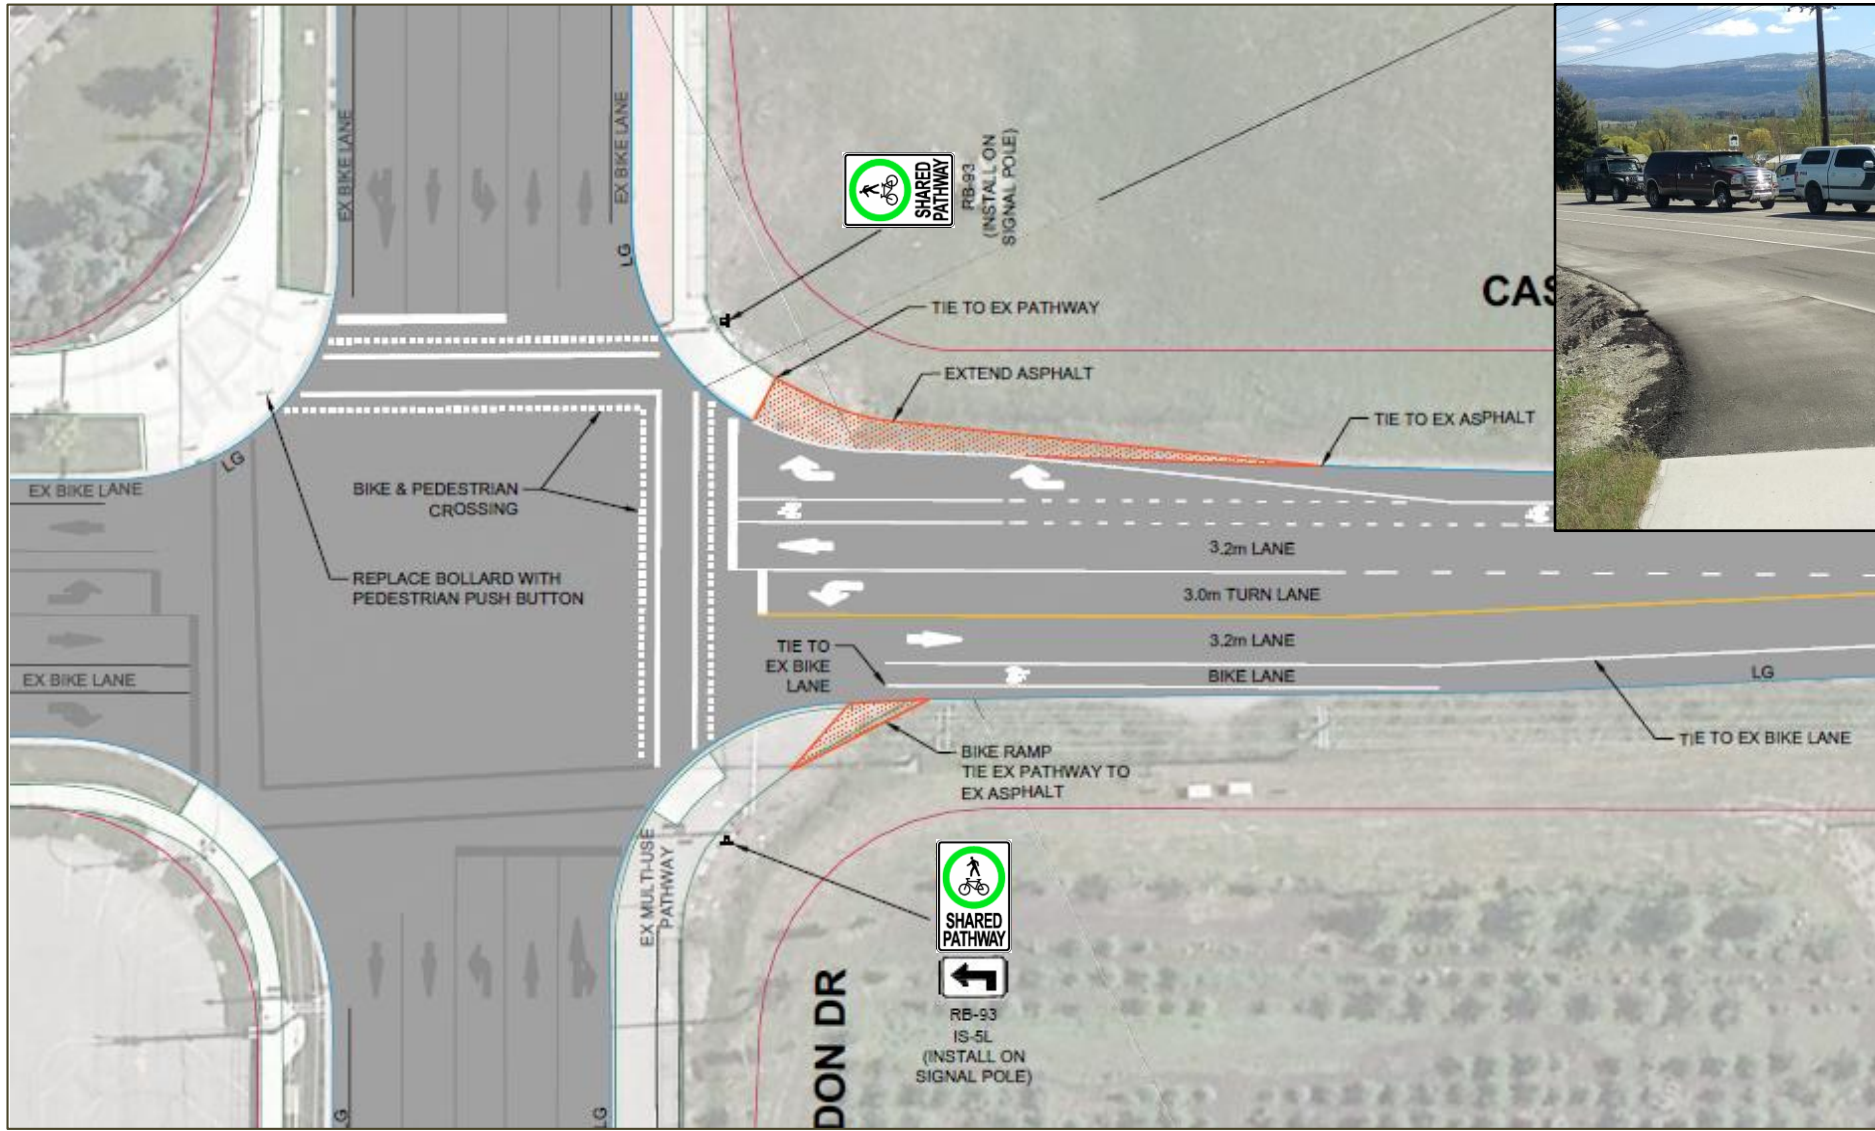
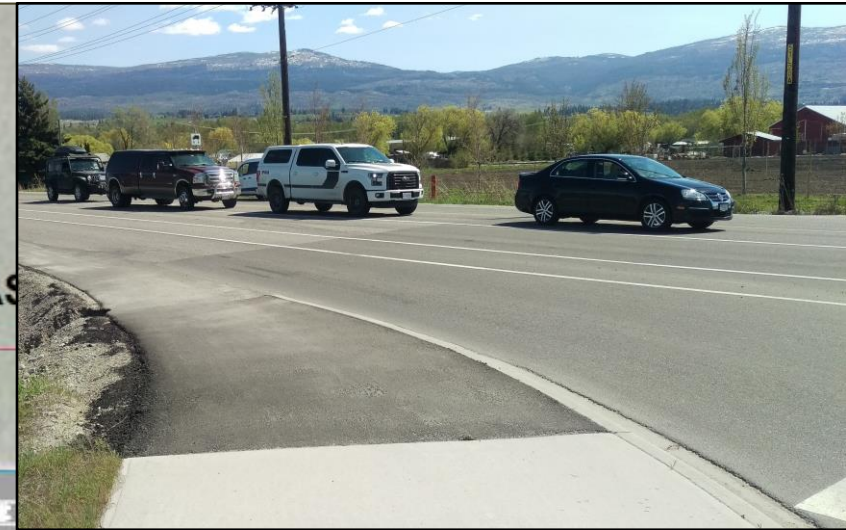
DESIGN – FORMALIZE RIGHT-TURN LANE

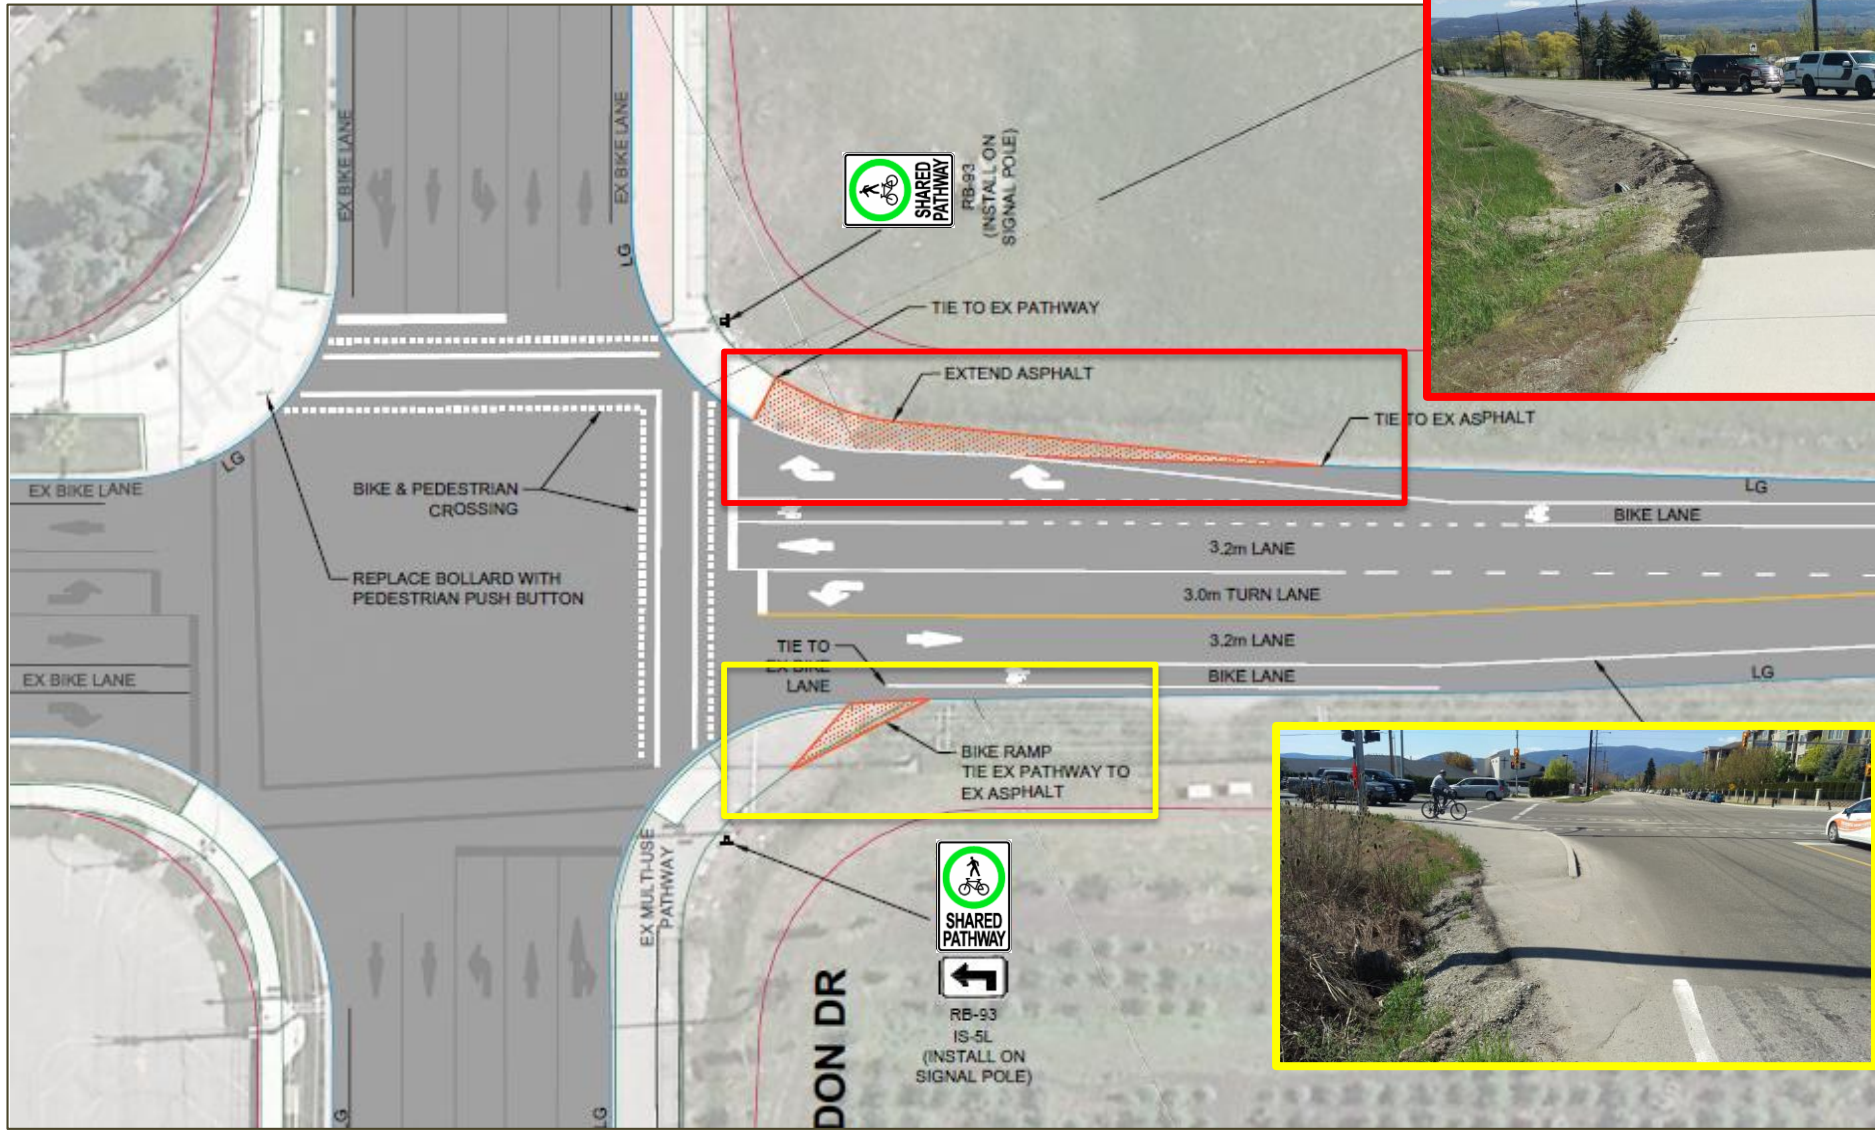
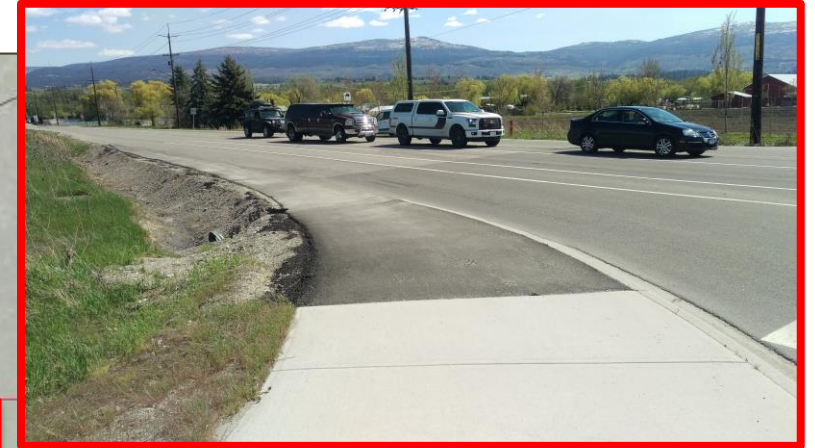
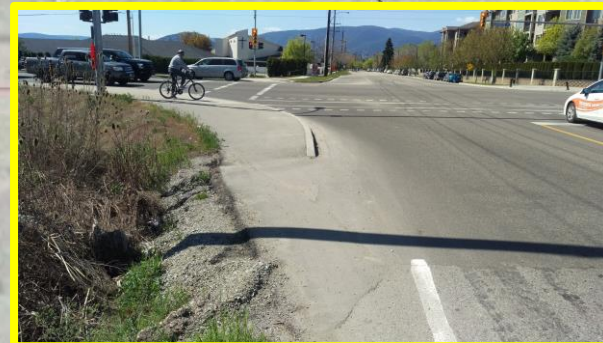
DESIGN – FORMALIZE BIKE RAMPS

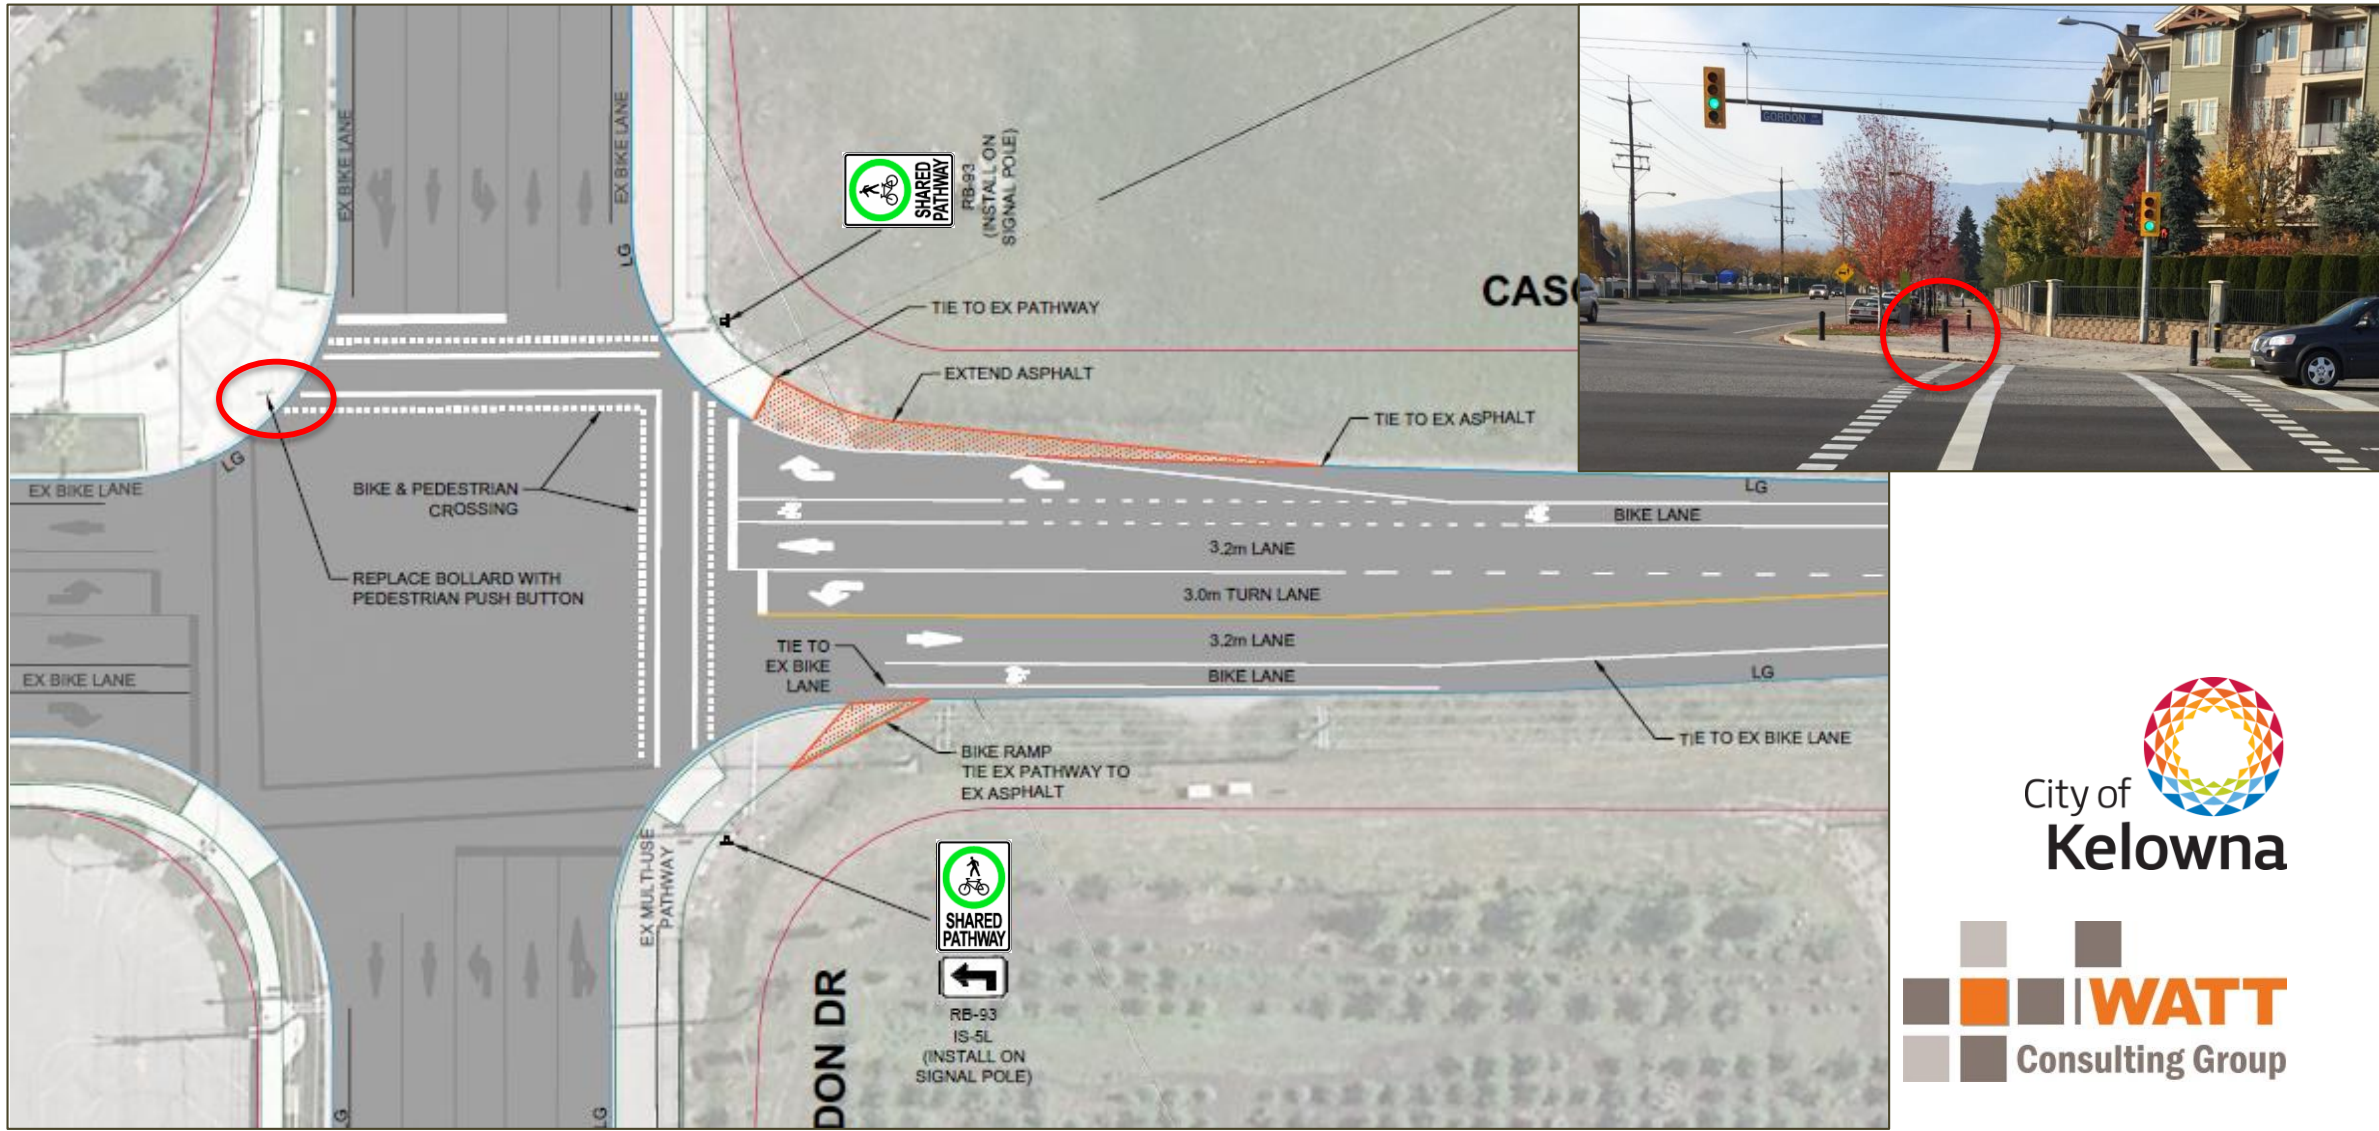
REPLACE BOLLARD WITH PUSH BUTTON
